INSPECTION REPORT

For the Property at:
100 INSPECTION ST
TACOMA, WA 98405

Prepared for: EXAMPLE REPORT
Inspection Date: Tuesday, September 26, 2023
Prepared by: Chad Fletcher

RE: Report No. 1366, v.0
100 Inspection st
Tacoma, WA
98405

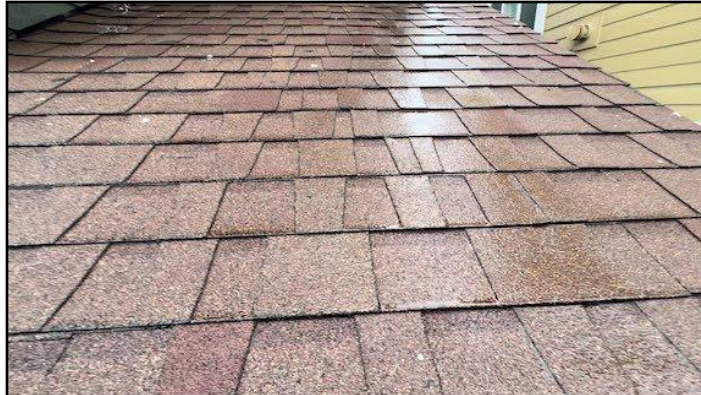
1. Granule loss

Condition: • [Granule loss](#)
Granule loss is a way to help judge the condition of the roof. The roof is approximately 20 years old. Typical life expectancy for architectural shingles is around 25 years sometimes more and some less.

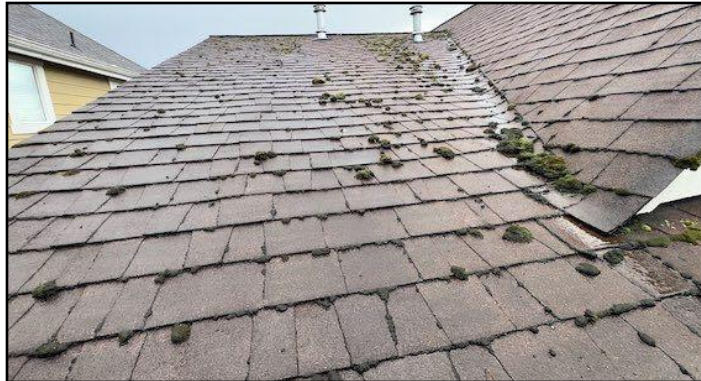
2. Debris/moss

Condition: • Debris/moss

Task: Clean roof moss

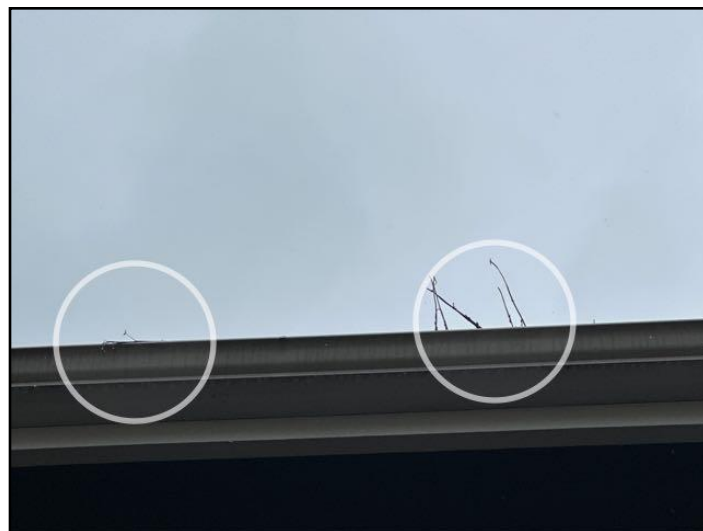
3. Dirty/debris

Condition: • Dirty/debris
There are plants growing in the gutters
Task: Clean out gutters

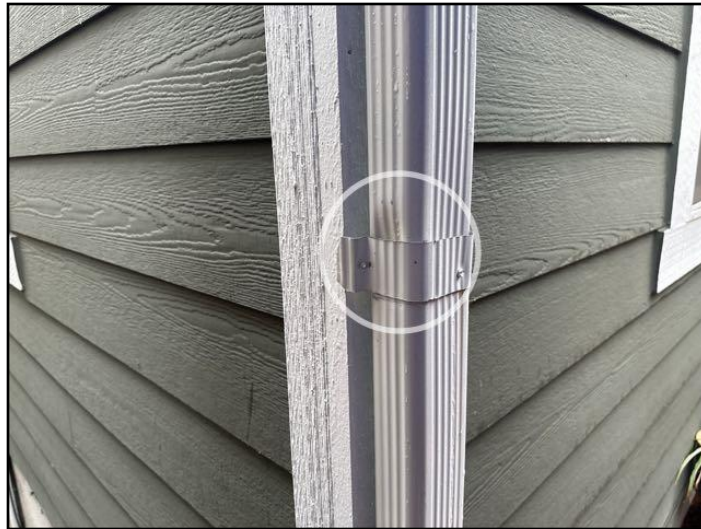
4. Connections loose

Condition: • [Connections loose](#)
Downspout is missing screws. Make sure to caulk around screw holes to protect trim.
Location: NE corner

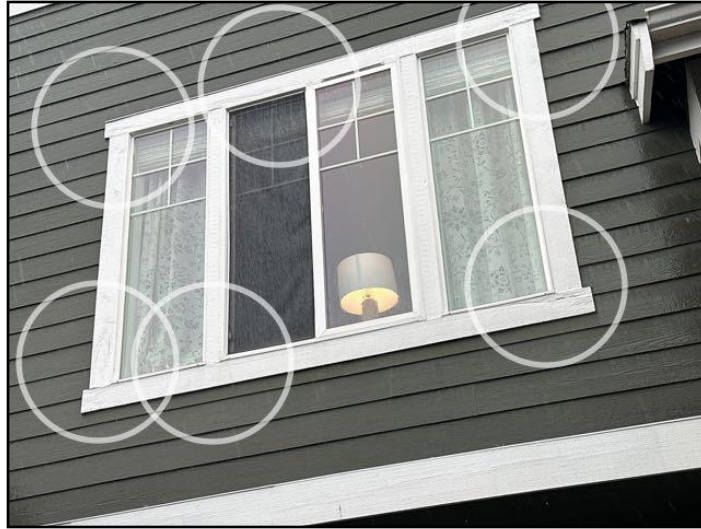
6. Rot

Condition: • [Rot](#)

Location: Front window

Task: Further evaluate and replace rotten trim.

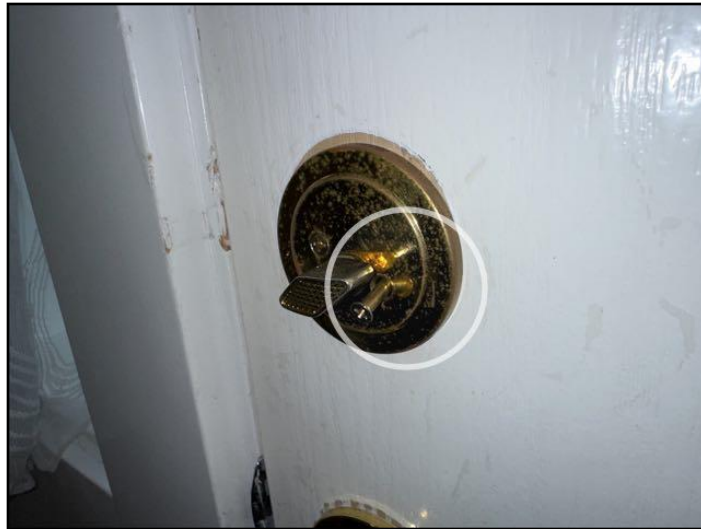
7.

Condition: • The front door deadbolt is loose, has a loose screw, and slightly misaligned.

Task: Repair or replace

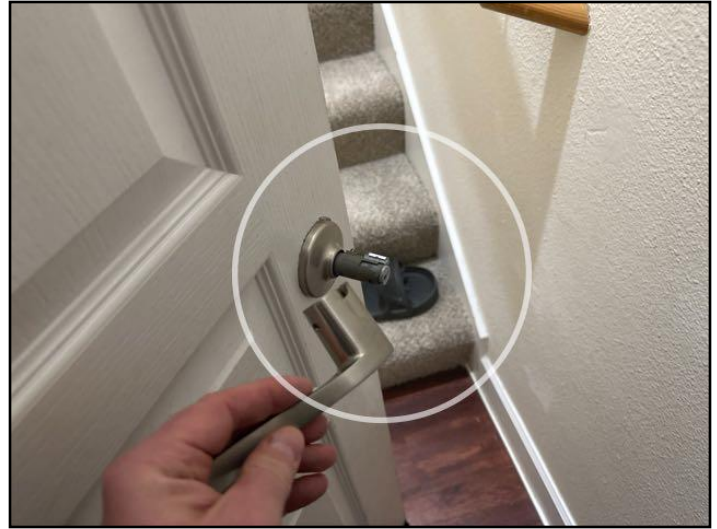
Condition: • The garage door to living space won't lock, is loose, and pieces are falling off

Task: Repair or replace

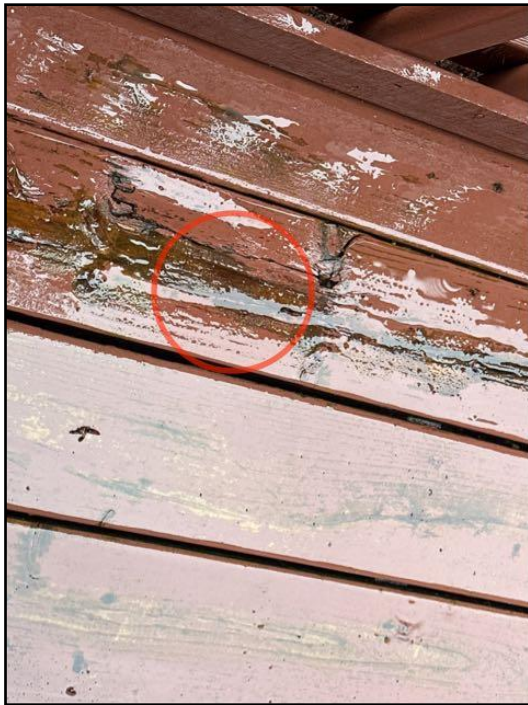
10. Rot

The back porch has rot in a few places. The skirting is in contact with the soil and has rot. The railings and various other spots have rot. The posts are in contact with soil and also have rot.

Task: Further evaluation by qualified professional recommended to repair or replace and correct issue as needed.

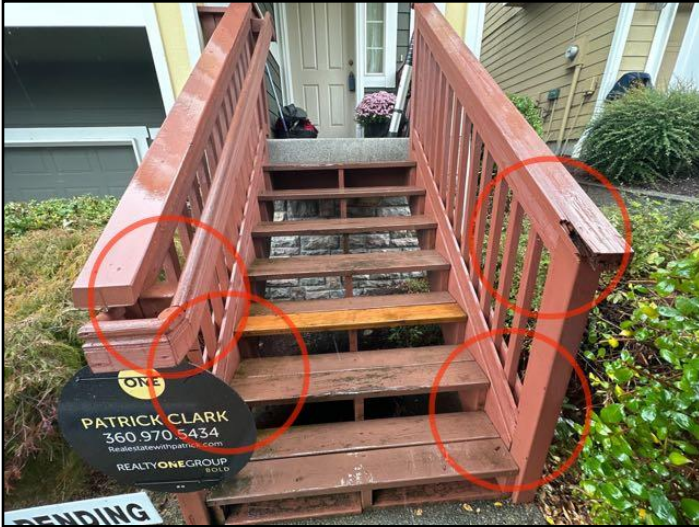
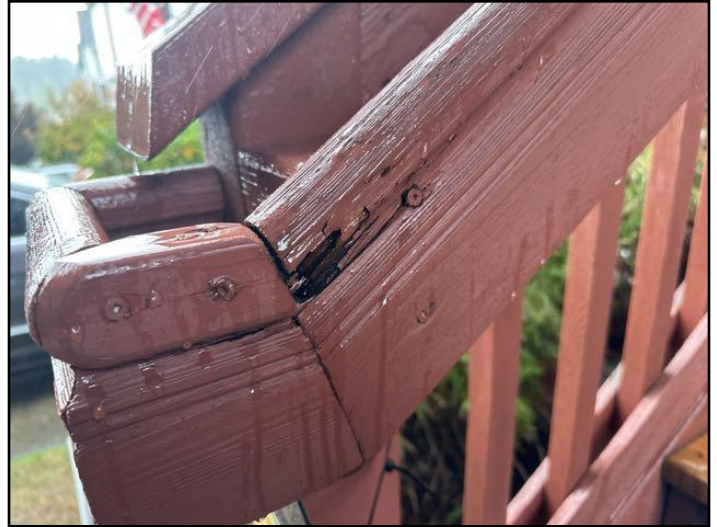
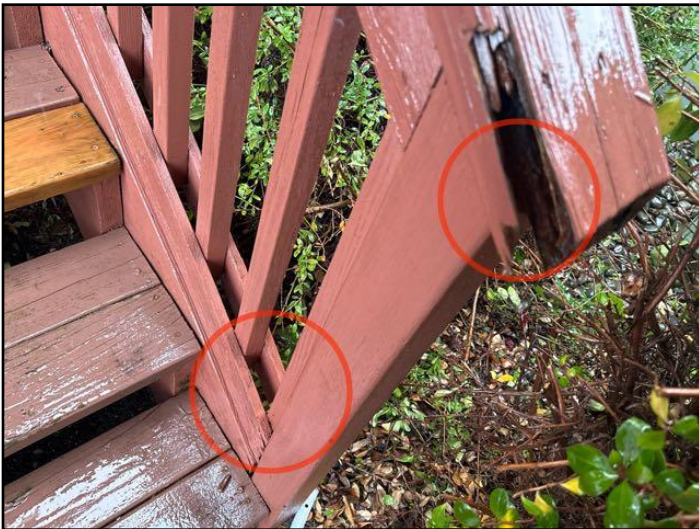
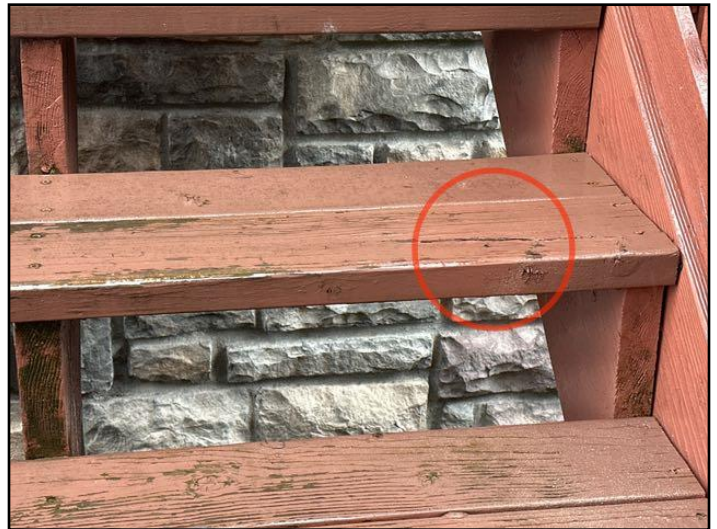
Rot in front stairs. A floor board was replaced but most floor boards still have some rot and loose screws. The railing and steps are a safety hazard.

Location: Front stairs in multiple spots on hand rails, guardrails, skirting, and some of the steps.

Task: Further evaluation by qualified professional recommended to repair or replace and correct issue as needed.

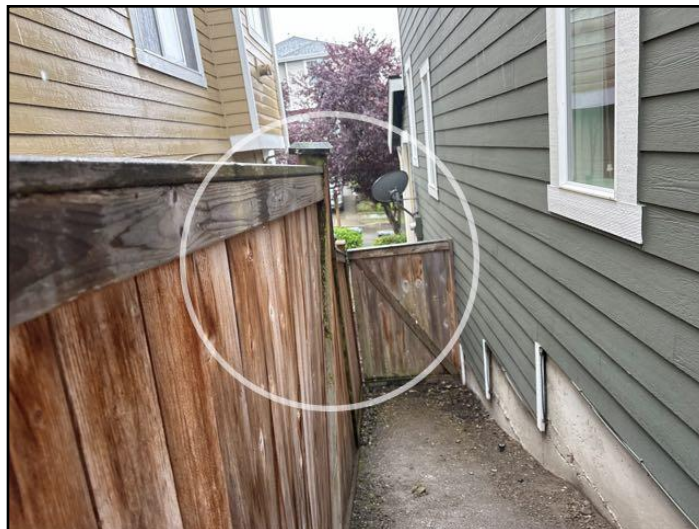
17. Leaning

The fence is leaning and may have some rot

Task: Repair

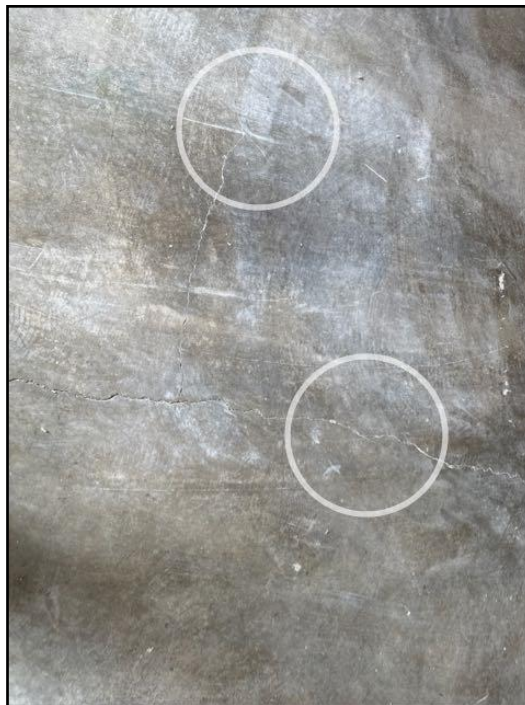
18. Cracked

Typical minor cracks on the garage floor

Task: Seal cracks

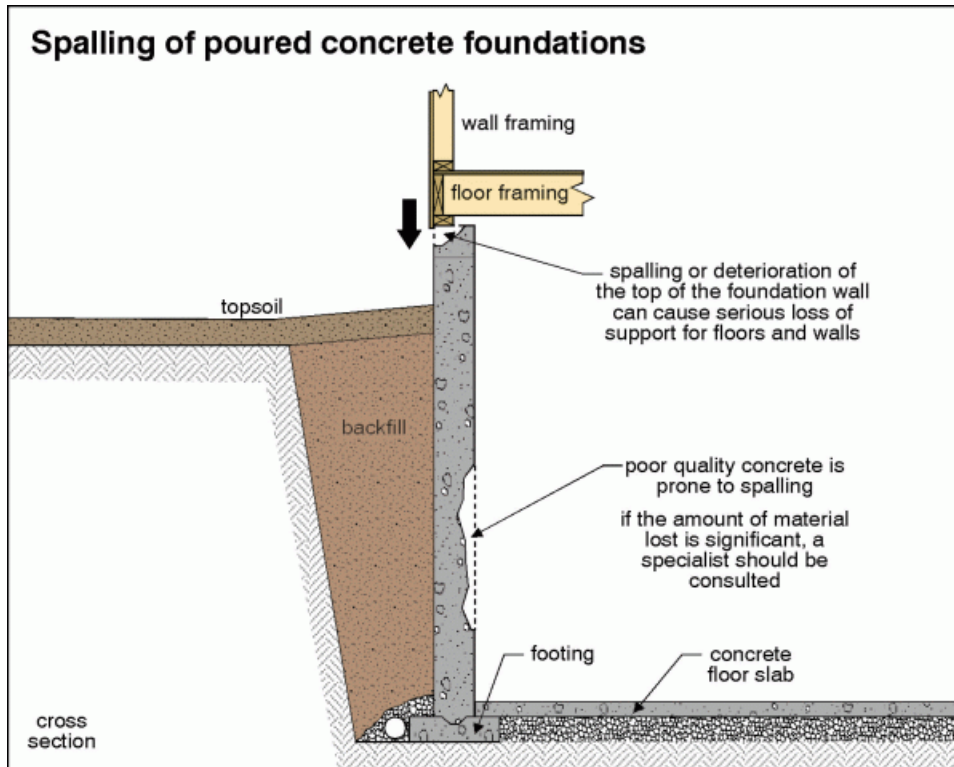
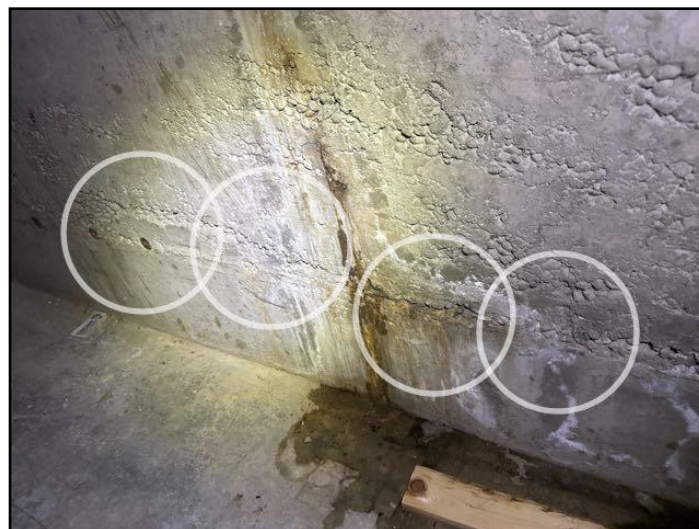
24. Spalling, crumbling or broken material

Condition: • [Spalling, crumbling or broken material](#)

See wet floor comments for more information

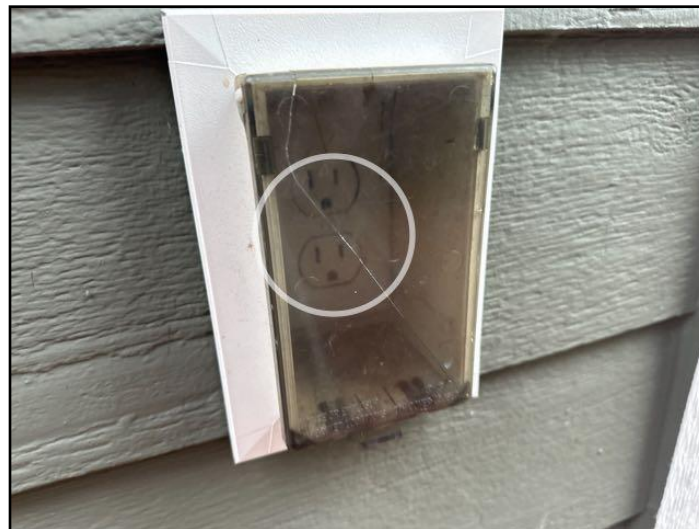
28. Damage

The outlet cover is cracked. Recommend replacing to help prevent water and or moisture from getting in. The cover is also difficult to open and I was unable to open it up without excessive force and didn't want to damage it further.

Location: Back porch

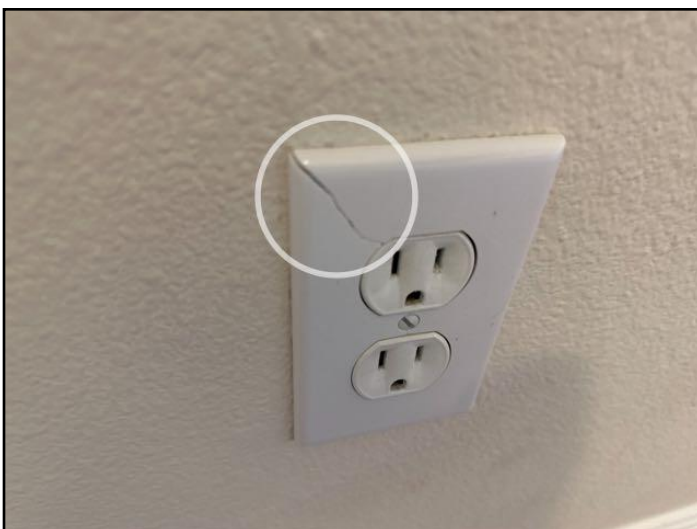
29. Damaged

Condition: • [Damaged](#)

Task: Replace cover plate

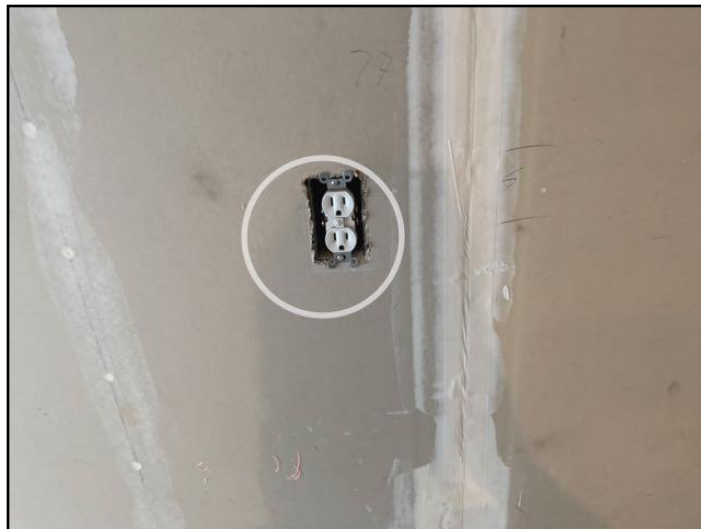
31. *Missing*

Condition: • [Missing](#)

Location: Garage

Provide cover plate

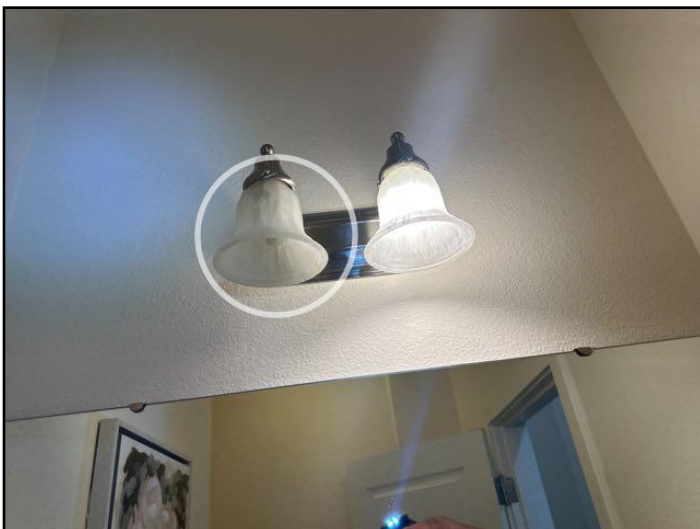
32. *Inoperative*

Condition: • [Inoperative](#)

Location: Downstairs bathroom, light above fireplace, the garage door light

Task: Replace light bulbs and further evaluation if that doesn't work.

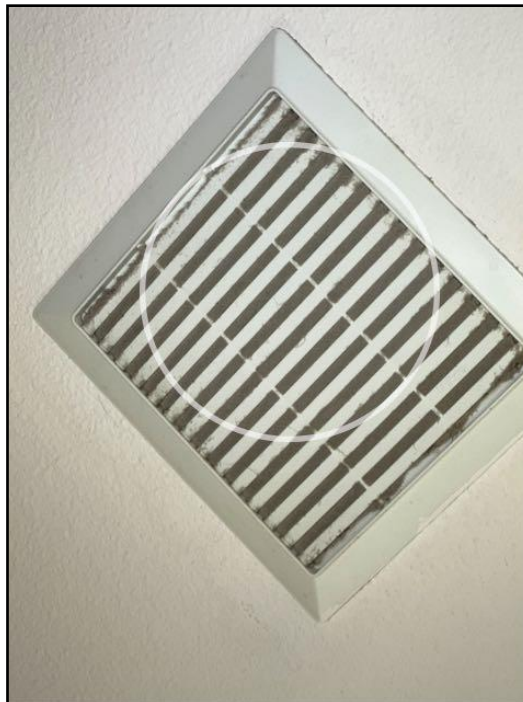
36.

Condition: • Primary bedrooms bathroom exhaust vent is clogged

Task: Clean vent

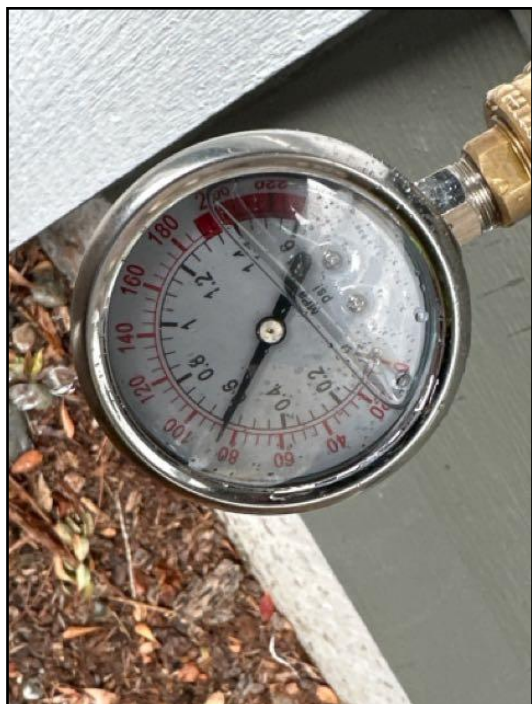
47. Recommended due to high supply water...

Water pressure is too high. Recommend adjusting the water pressure to between 40-80PSI. Pressure regulator is in garage.

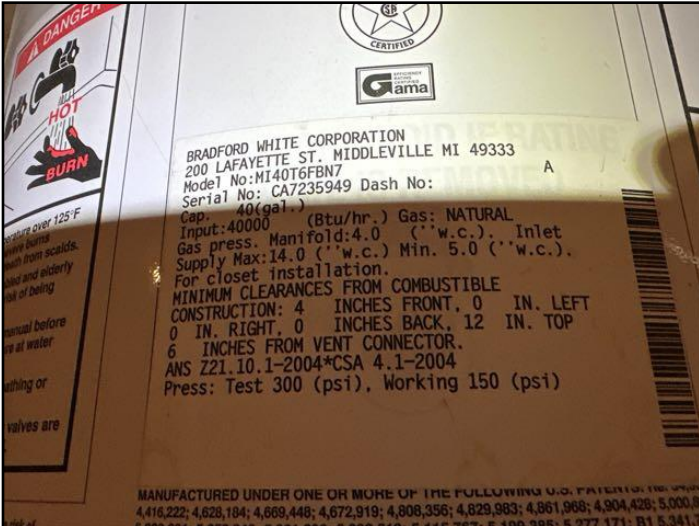
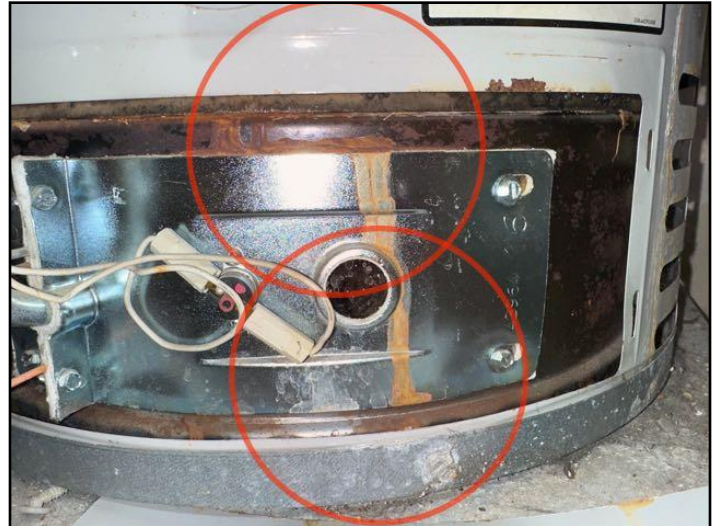
The water heater appears to be a 2006. The tank is rusting, appears to have had leaks, and the water piping has been leaking in the last with heavy corrosion.

Task: Replace water heater and piping

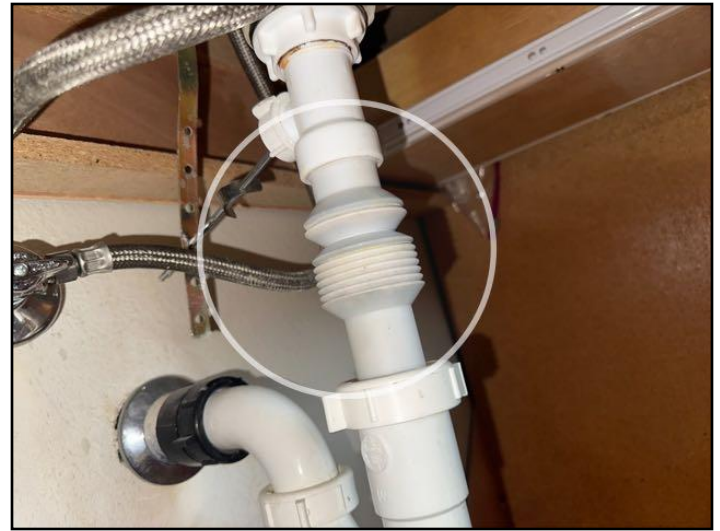
Condition: • The drain pipe is flex pipe. Only smooth surface pipe is recommended to help prevent clogging.

Location: Kitchen sink. Primary bedrooms bathroom.

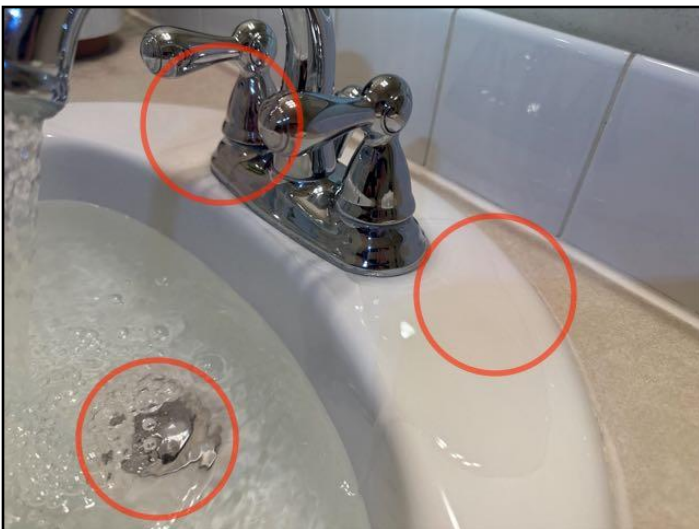
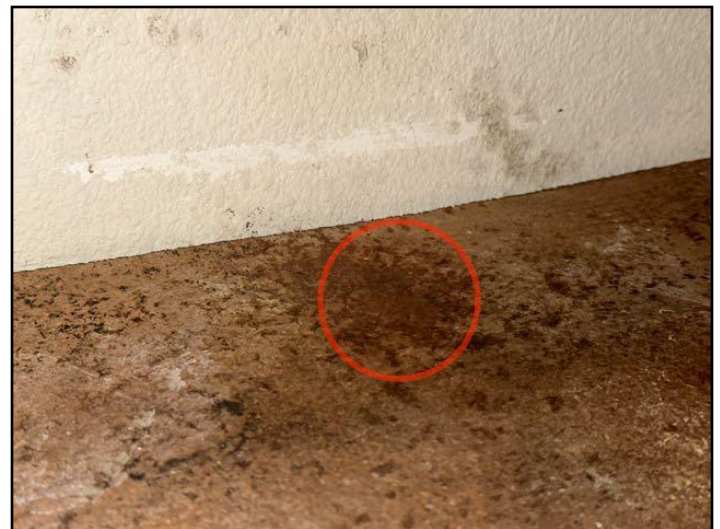
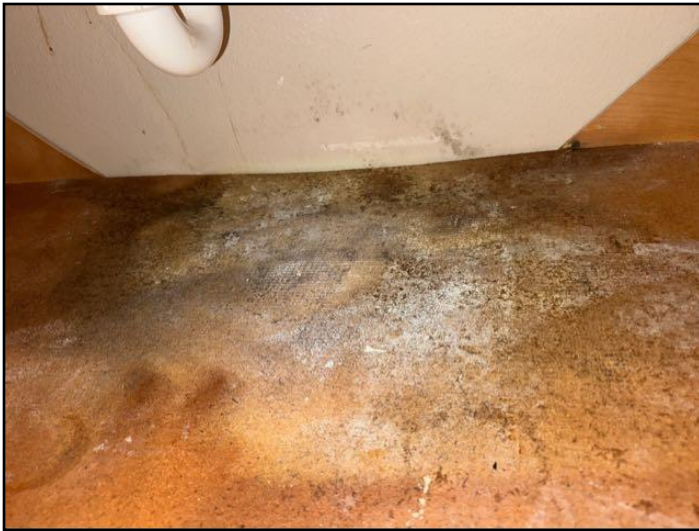
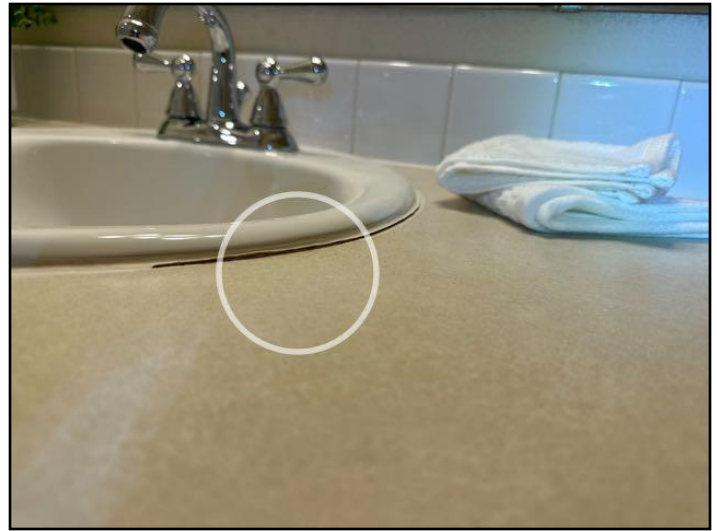
The upstairs hallway sink faucet handles leak onto the countertop and into the cabinet when turning on. There is water damage and discoloration or possible organic growth in the cabinet. The drain stop the the faucet also does not work so the sink is draining very slowly. The sink is not caulked around the edges which may allow water to penetrate into sink cabinet.

Task: Further evaluation. Replace faucet. Clean sink cabinet with dish soap then bleach. Caulk around sink where it contacts counter top.

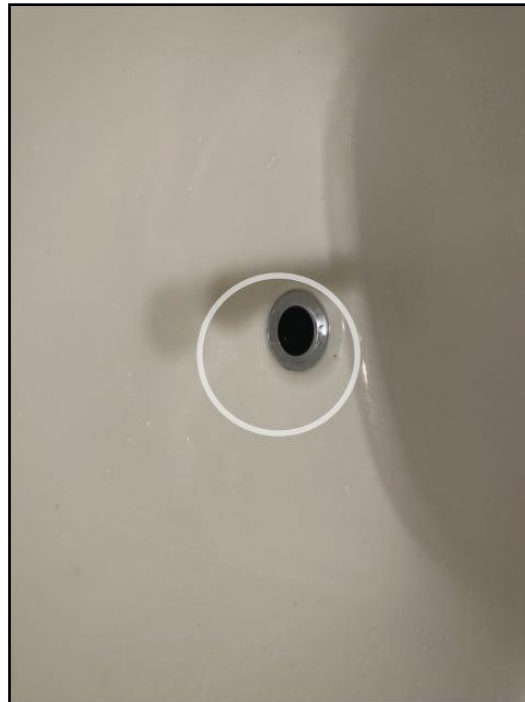
59. Drain stop missing

Condition: • Drain stop missing
Location: Downstairs bathroom sink
Task: Add drain stop if needed

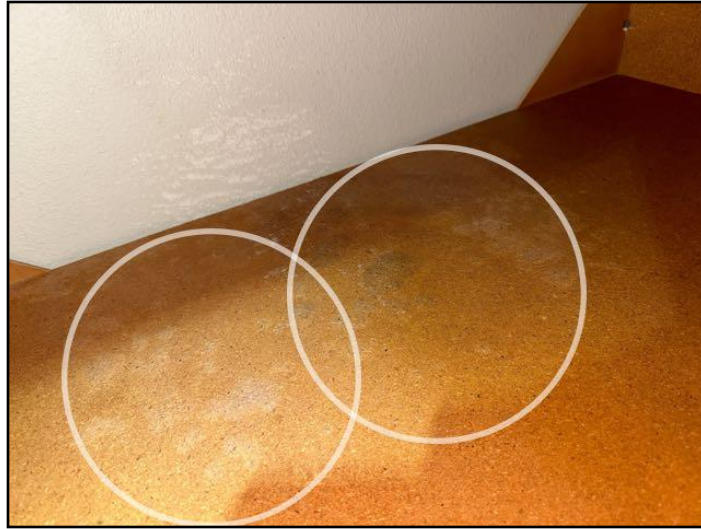
60.

Condition: • Most of the cabinets have damage to the bottoms of the cabinets.

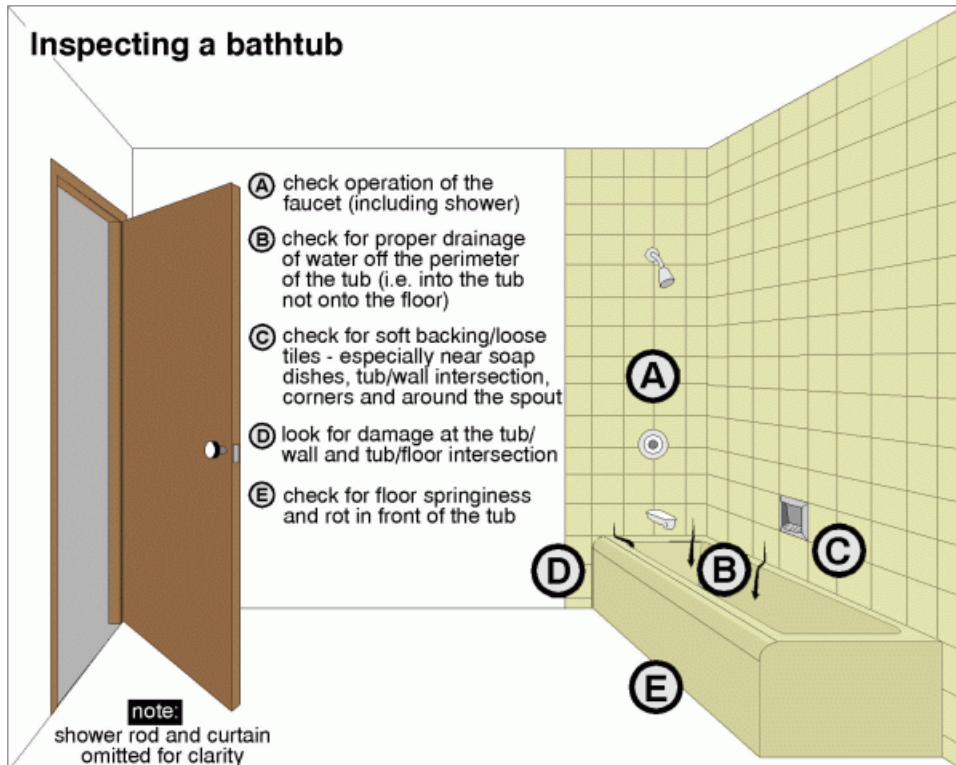
The bathtub has a slow drain, sometimes this is caused by a clogged P-trap or the rubber drain stop gasket is loose and slowing down drain flow.

Task: Further evaluation and correct

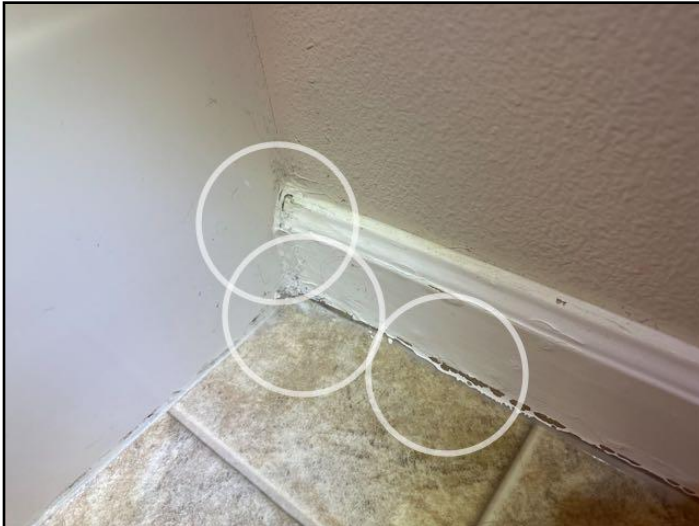
61.

Condition: • There is some swelling of the trim around the bathtub in a few spots in the upstairs hall and primary bedrooms bathroom. These areas should be caulked very well for shower overspray. The top edges of both shower enclosures also had some gaps in the caulking.

Task: Add caulk. Replace baseboard if needed

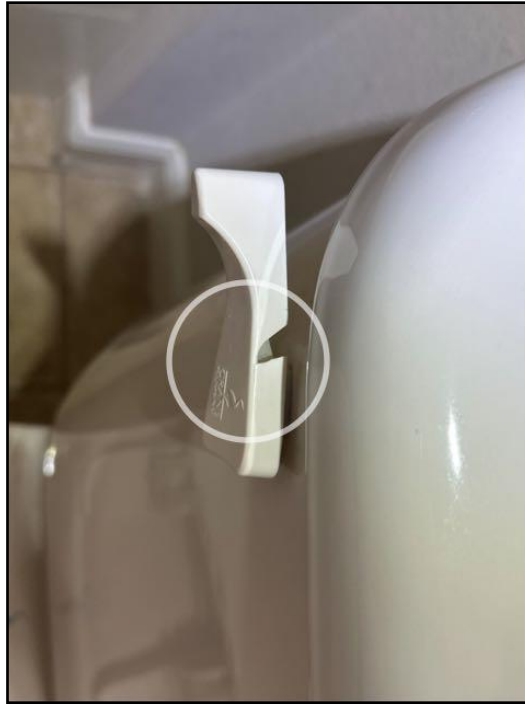
64.

Condition: • The toilet flush mechanism has a crack in it.

Location: Primary bedrooms bathroom

Task: Replace as soon as practical

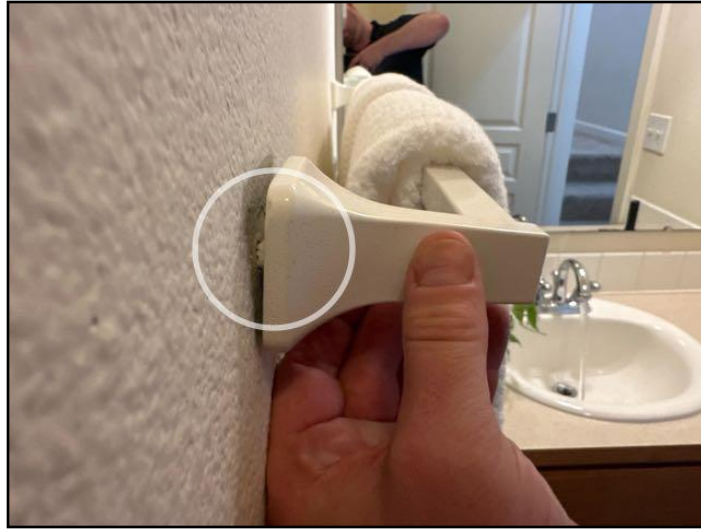
66.

- Condition:** • The towel rack is not secured well
Location: Downstairs bathroom, upstairs hallway bathroom, primary bedrooms bathroom.
Task: Repair or replace

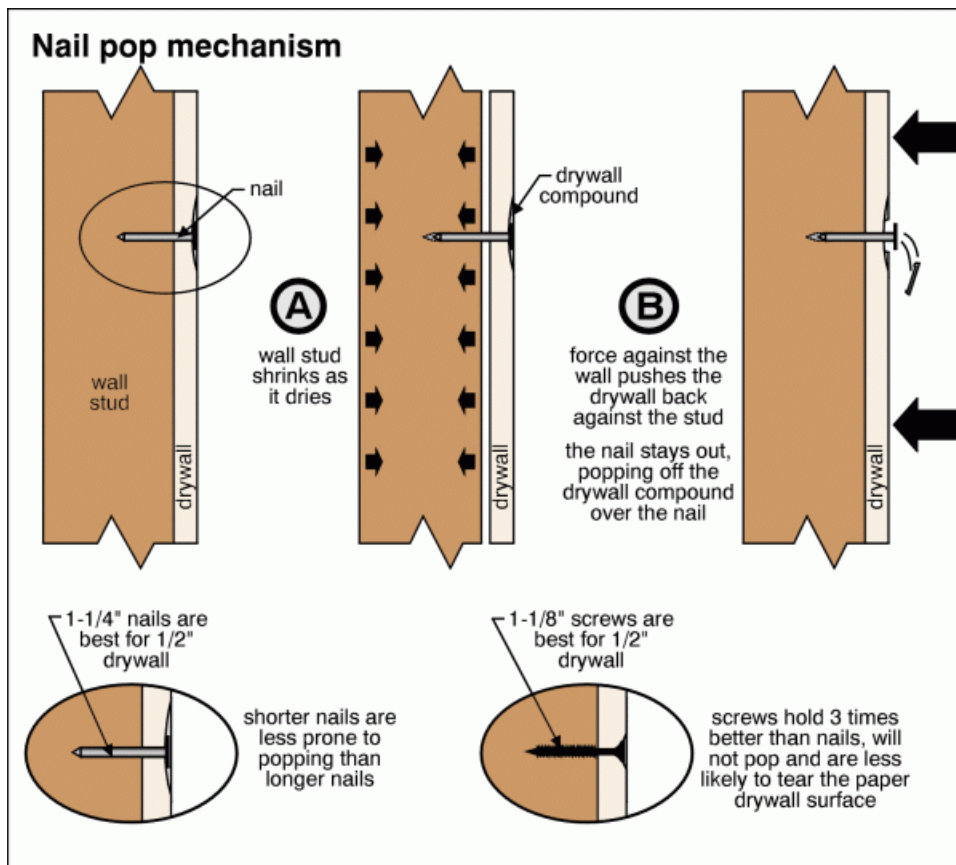
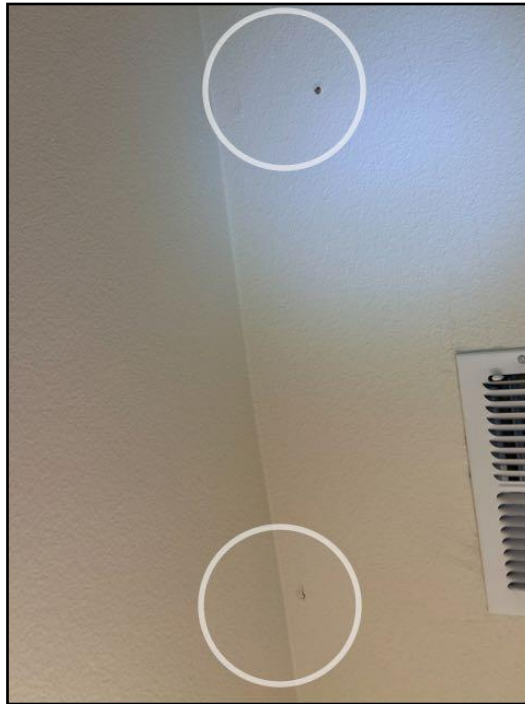
67. Nail pops

Nail pools can be common with ceilings especially with trusses. There are various nail pops throughout the home main floor and upstairs on the walls.

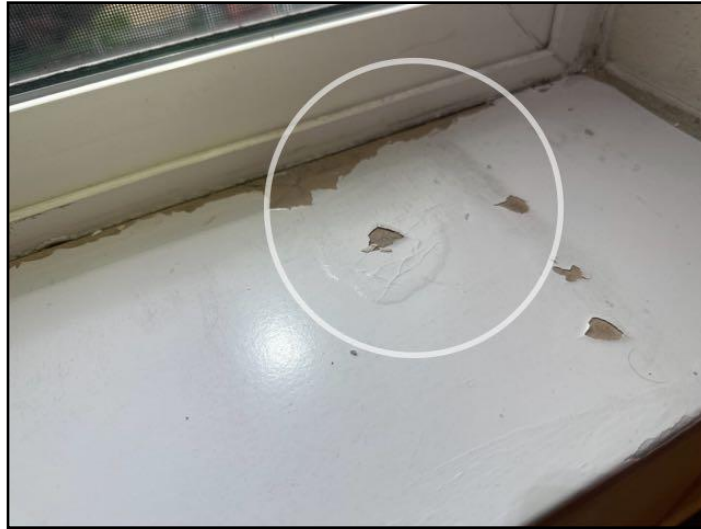
70.

Condition: • Primary bedroom window sil has moisture damage. Possible window left open.

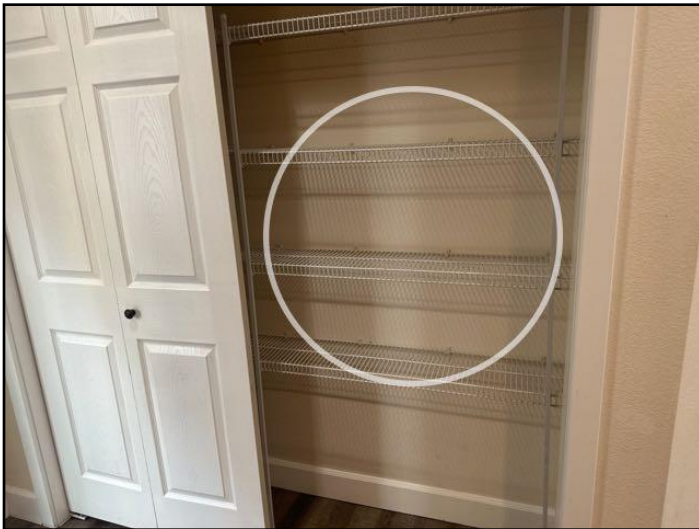
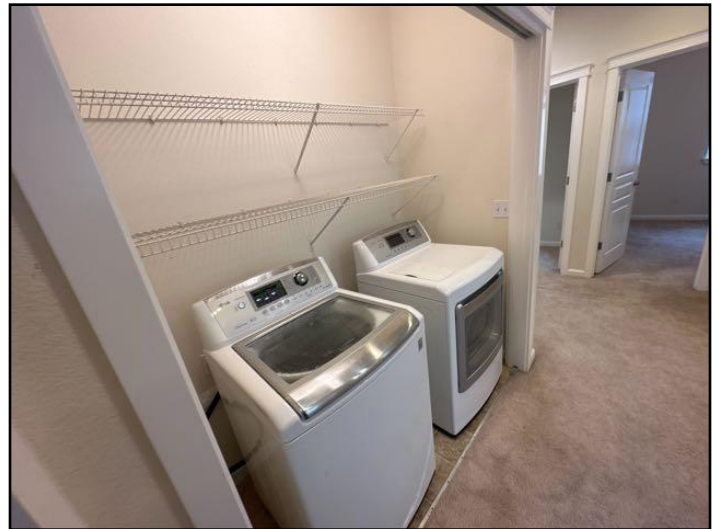
Condition: • Pantry door missing as well as laundry room doors.

Task: Provide doors

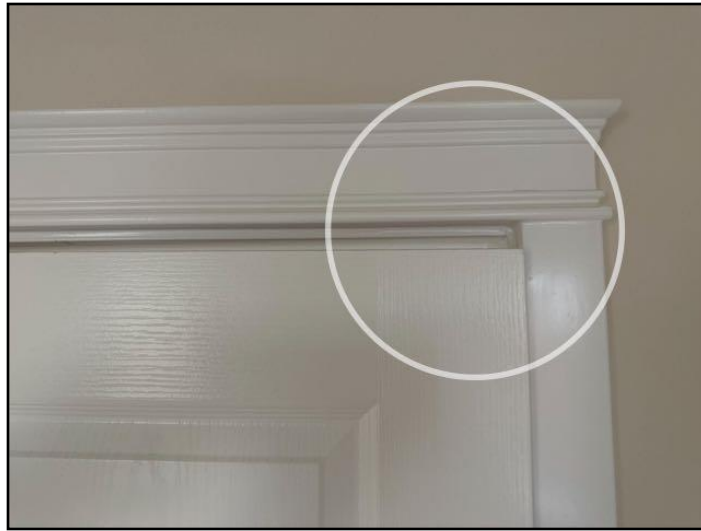
73.

Condition: • Some of the doors are offset and catching.

Task: Correct/repair

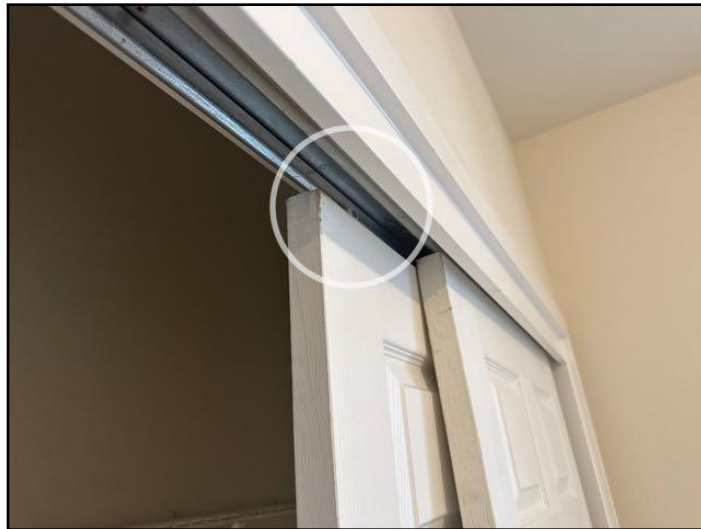
74.

Condition: • Closet door on NE corner is off the rails. The NW closet door doesn't have guides on the floor and swings.

Task: Repair as soon as practical

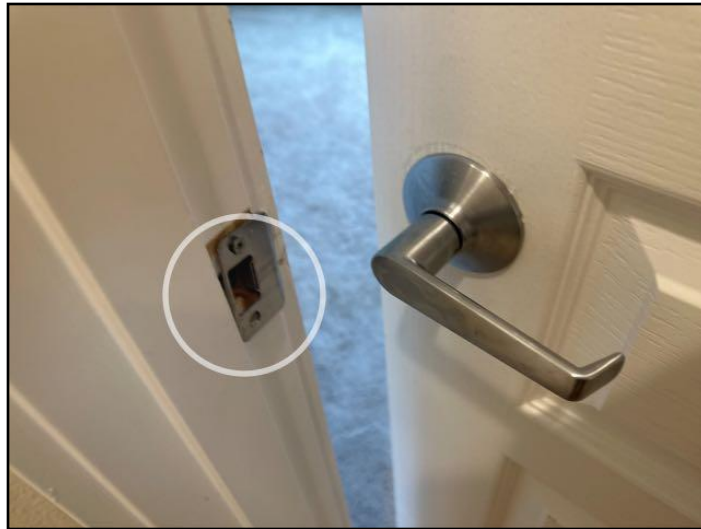
75. Loose

Door hardware is loose, missing a screw, and door does not latch

Task: NW bedroom door

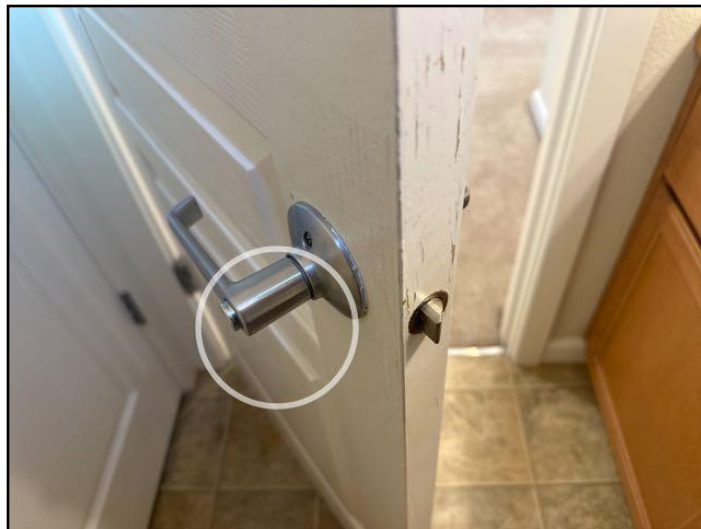
76.

Condition: • The privacy lock for the upstairs hallway doesn't work. Privacy lock for primary bedrooms bathroom is missing.

Task: Replace handle and lock. Add lock if needed

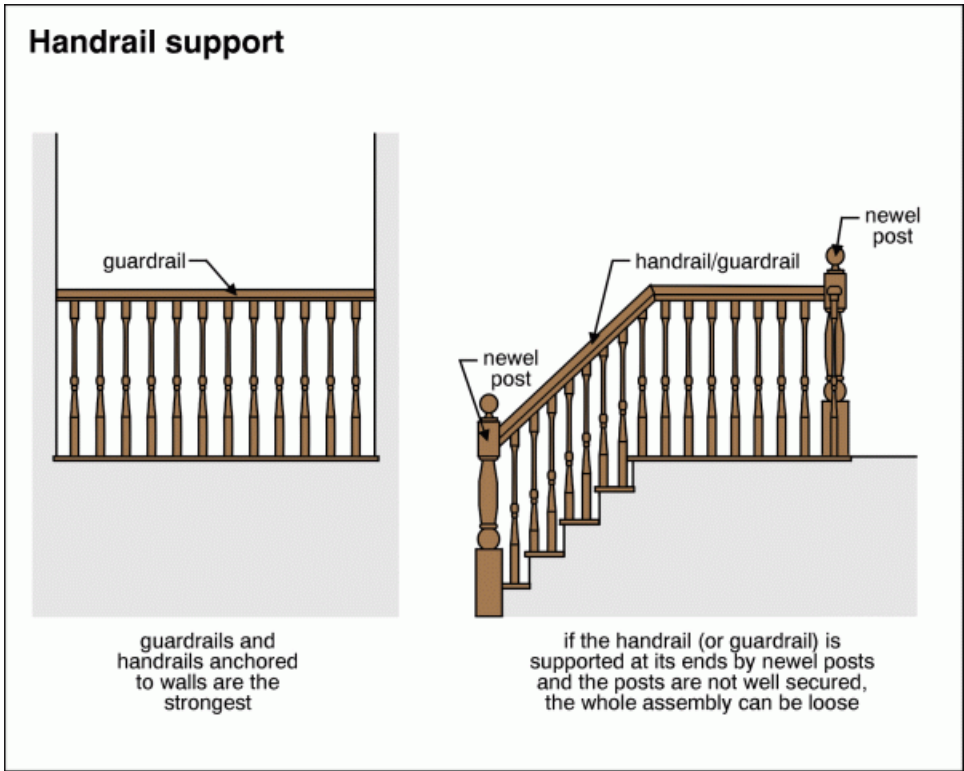
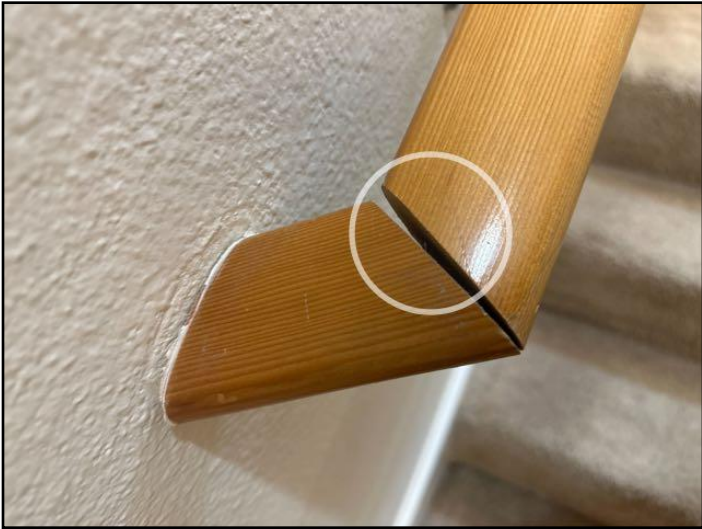
77. Loose

The handrail bottom edge is loose. Repair or replace

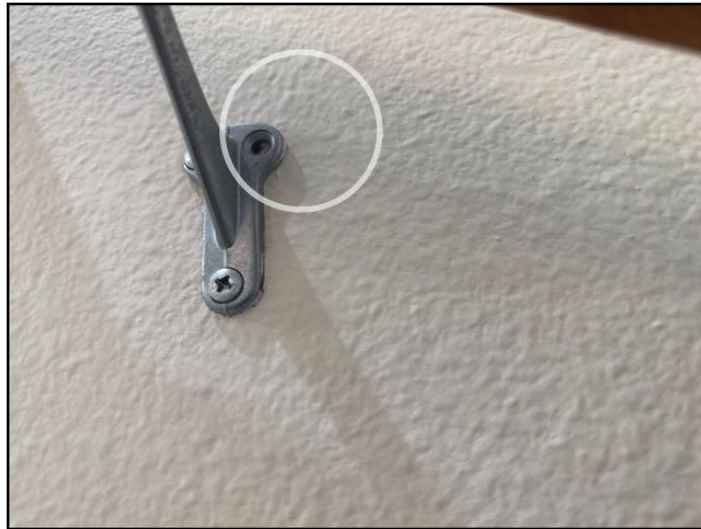
78.

Condition: • Two screws missing on handrails near front door. One missing on top and bottom of railing.
Task: Add screw.

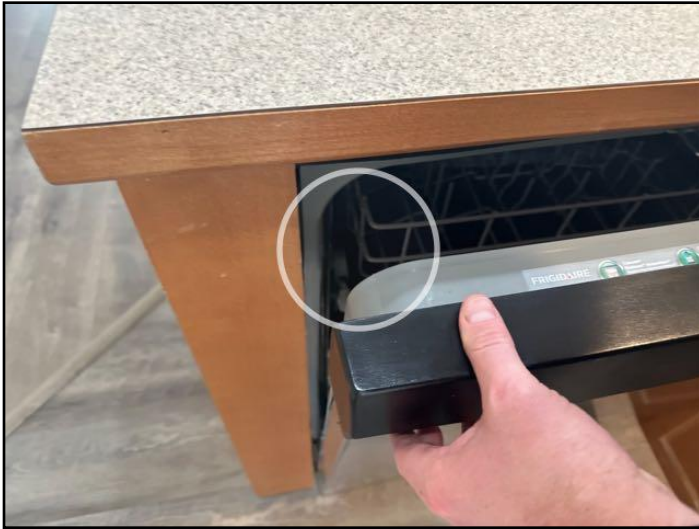
81. Inoperative

The dishwasher door doesn't have a good seal which will allow for leaking. The water valve was shut off. There is some water damage to the trim near the dishwasher

Task: Replace dishwasher.

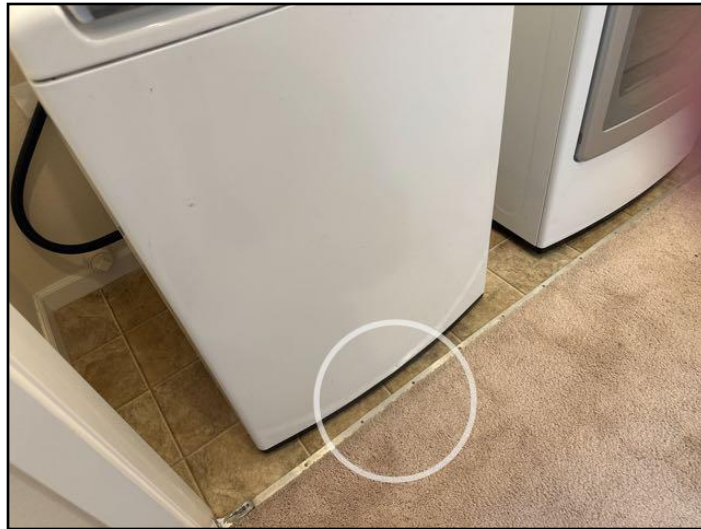
84. Drip pan missing

Drip pan missing. Provide drip pan.

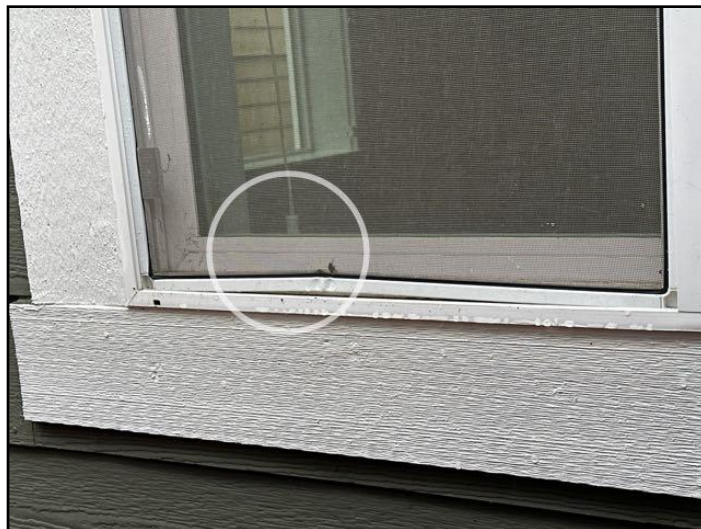
86.

General: • Bent window screen on NE corner. Repair/replace if needed

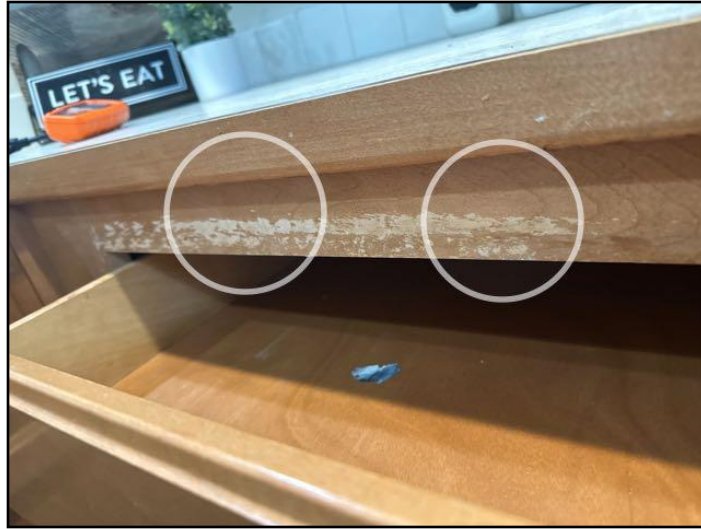
87.

General: • There is some cosmetic scraping on the cabinets in various spots. Kitchen cabinets, both bathroom cabinets.

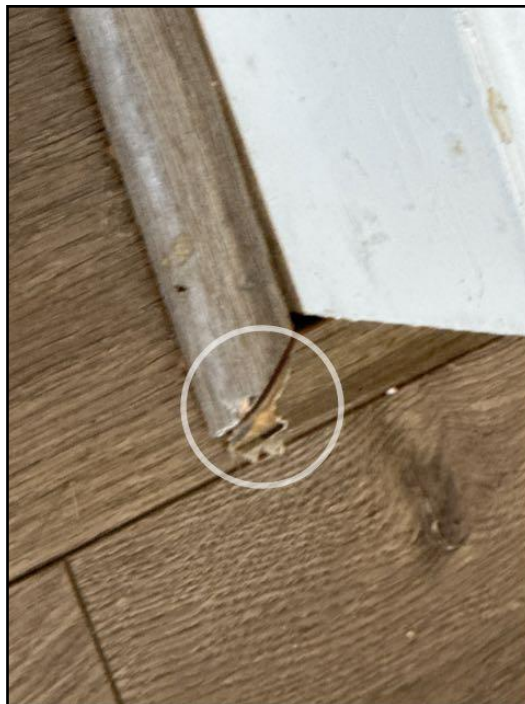
88.

General: • Minor damage to baseboard in kitchen. Cosmetic damage to various spots throughout

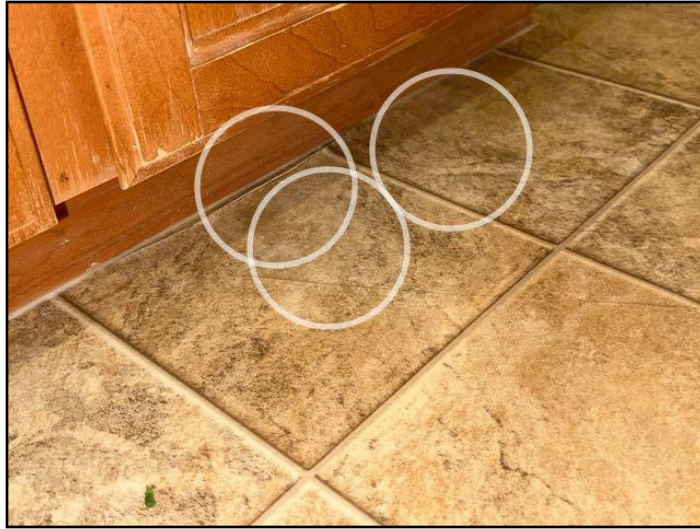
89.

General: • Scrapes in the bathroom flooring upstairs.

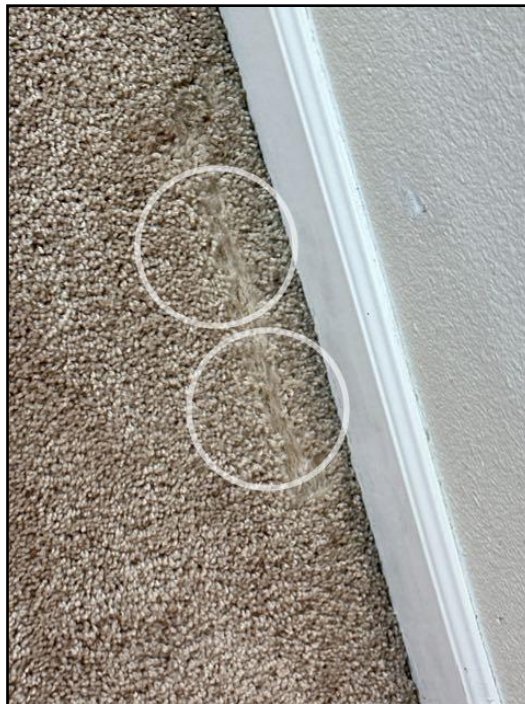
90.

General: • Some of the carpet appears to be loose and has some minor damage upstairs In NW bedroom and in various areas.
