INSPECTION REPORT

For the Property at:
200 INSPECTION ST
OLYMPIA, WA 98502

Prepared for: EXAMPLE REPORT
Inspection Date: Friday, September 22, 2023
Prepared by: Chad Fletcher

RE: Report No. 1362, v.0
200 Inspection St
Olympia, WA
98502

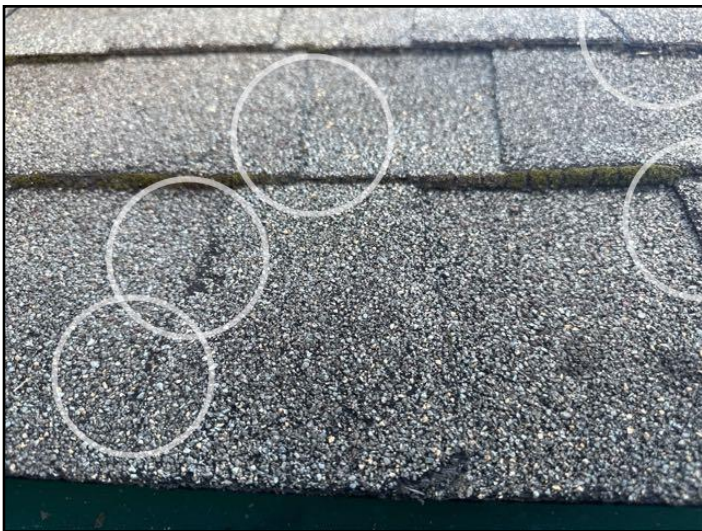
5. Granule loss

Condition: • [Granule loss](#)

Granule loss is one way to help gauge the age and condition of the roof. The granules on the roof are loose and starting to come off. You can see inside of the gutters. The roof is about 19 years old. Typical life expectancy for architectural shingles is 25 years.

Task: Budget for replacement

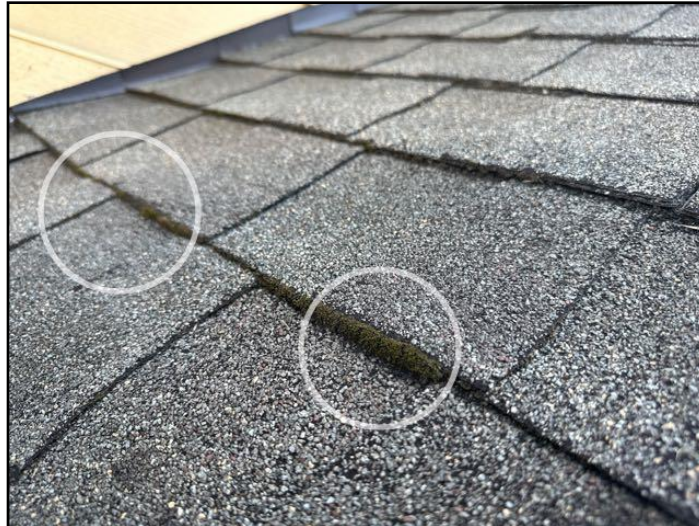
8. Debris/moss

Condition: • Debris/moss

Small amounts of moss build up. Recommend monitor and add treatment if more grows. Don't pressure wash.

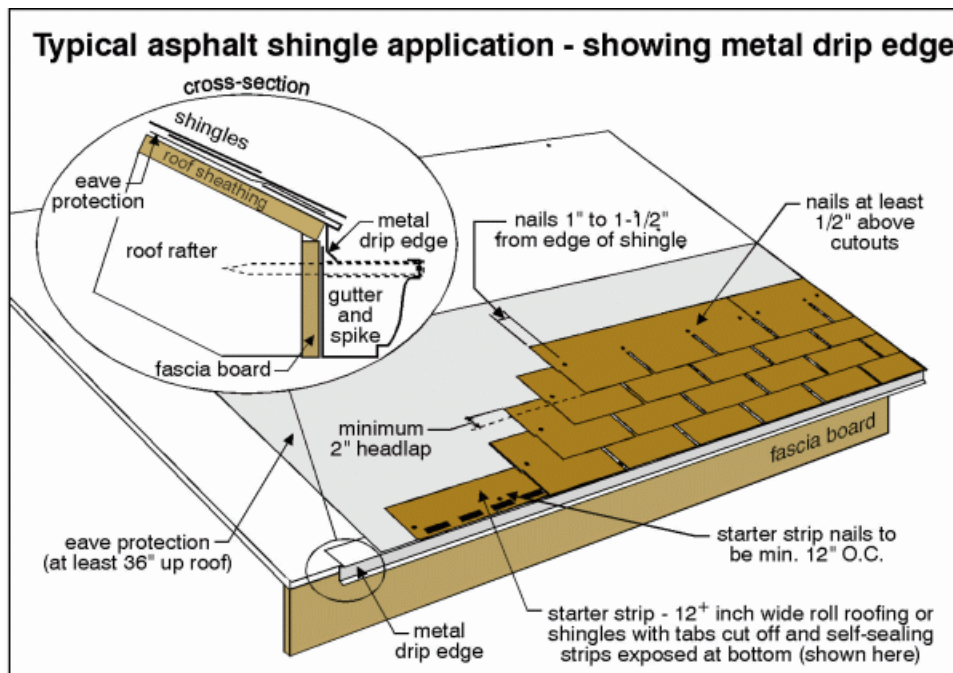
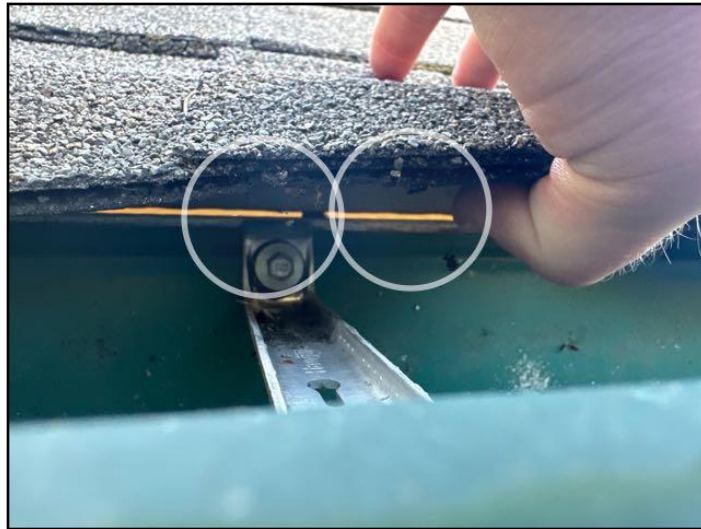
9. *Missing*

Condition: • [Missing](#)

Drip edge flashings weren't installed with roof. They were not required when the home was built. I did not see any visible damage to the roof sheathing or fascia but I recommend adding them when Re-roofing.

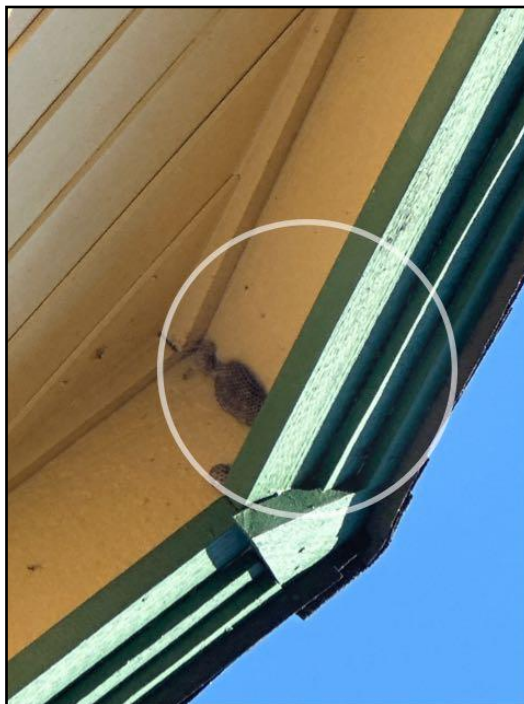
10.

Condition: • Bee nest on East wall, west wall near roof. Multiple spots throughout and in attic

Task: Remove nests for safety

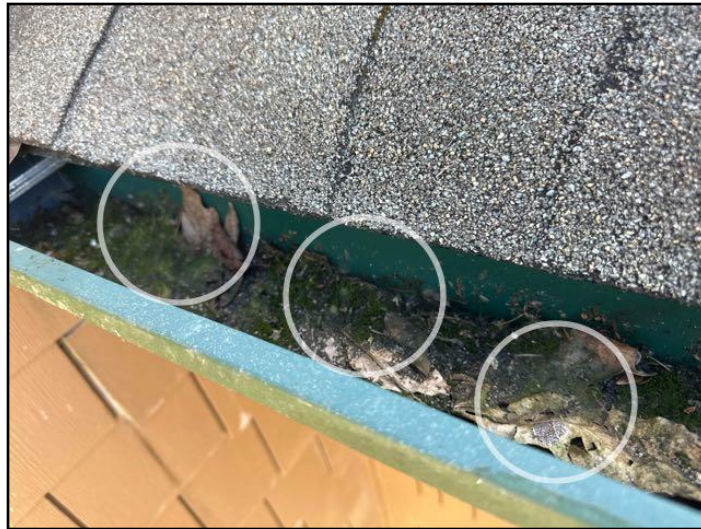
11. Dirty/debris

Condition: • Dirty/debris

Most of the debris in the gutters is roof granules and moss.

Task: Clean gutters

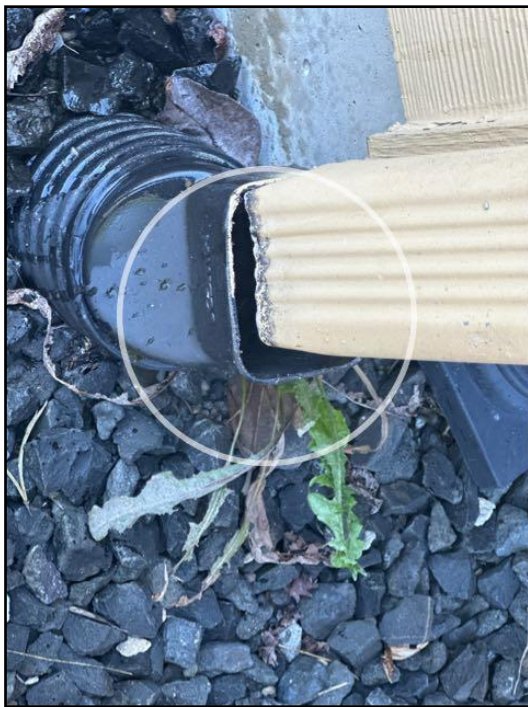
12.

Condition: • Partially disconnected downspout in front of house and more disconnected by garage.

Task: Correct

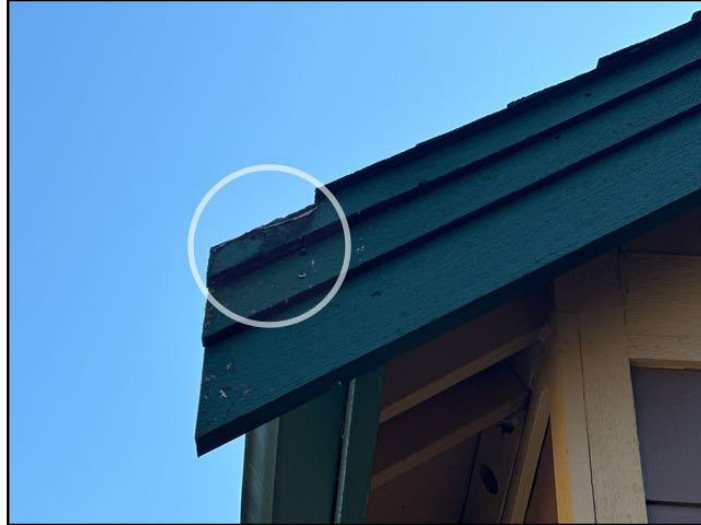
14. Paint - deteriorated / missing

Condition: • Paint - deteriorated / missing

Bottom edges of fascia typically get paint deterioration quicker than most spots.

Task: Recommend removing chipped paint, add new paint and monitor.

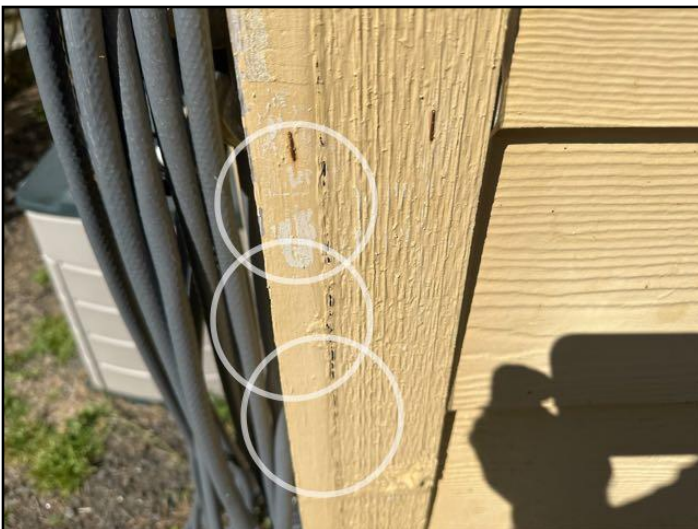
15. Caulking missing or deteriorated

Condition: • [Caulking missing or deteriorated](#)

Maintenance item. A couple years after homes are built wood shrinks and leaves gaps around trim. These small gaps typically will allow for water to enter and damage the wood. Recommend adding caulk to any windows, doors, or siding trim with gaps around the trim.

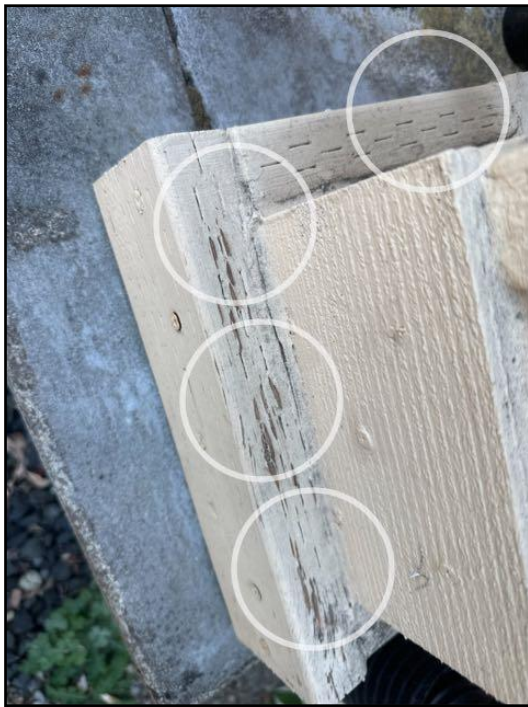
17. Paint or stain needed

Condition: • Paint or stain needed
Some paint is chipping

Task: Add paint

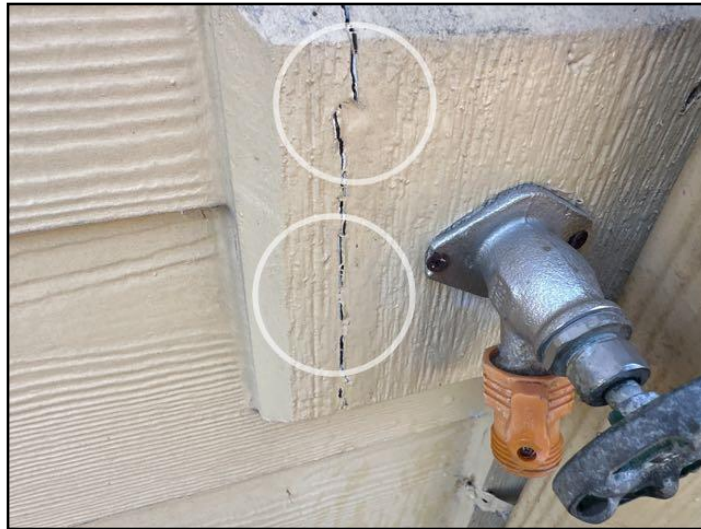
20.

Condition: • Recommend sealing gap in trim.

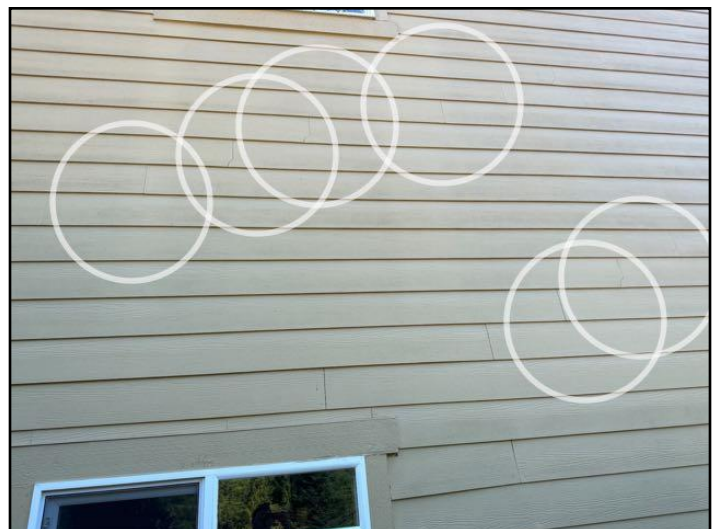
22.

Condition: • Minor damage to siding

Task: Seal gaps, add fastnet

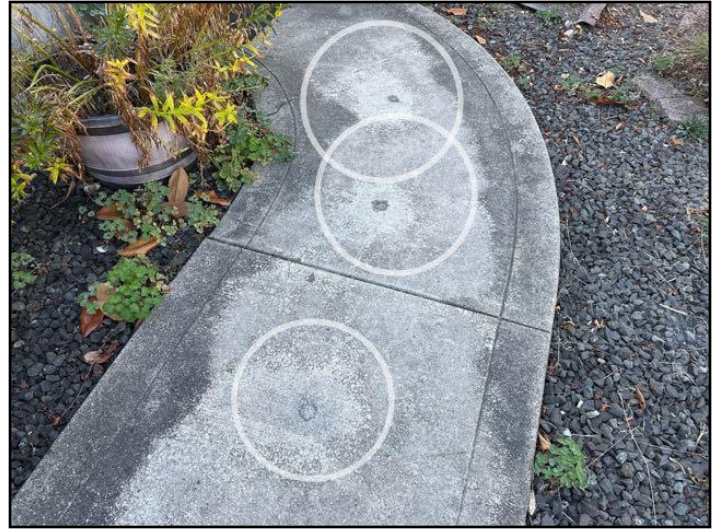
23.

Condition: • Settlement cracks on front porch. Repairs appear to have been done. Circles may indicate slab jack

Task: Monitor and fill gaps if needed

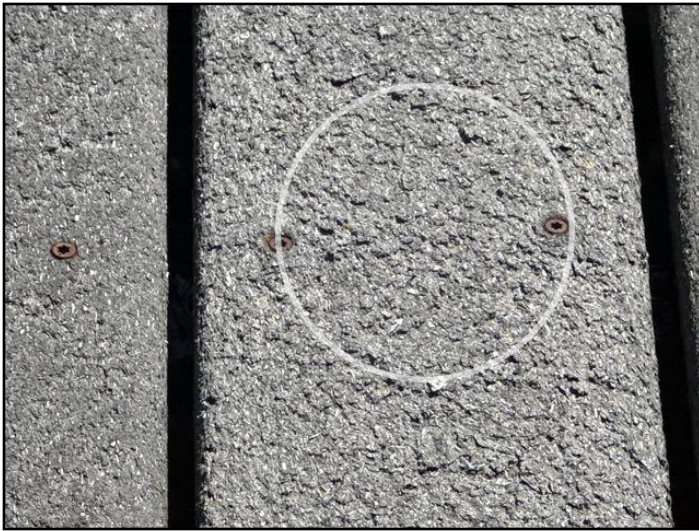
26.

Condition: • The trex decking is showing signs of deterioration in various spots throughout. If deterioration continues the screws may start to come loose and the boards may not be safe.

Task: Budget for board replacements

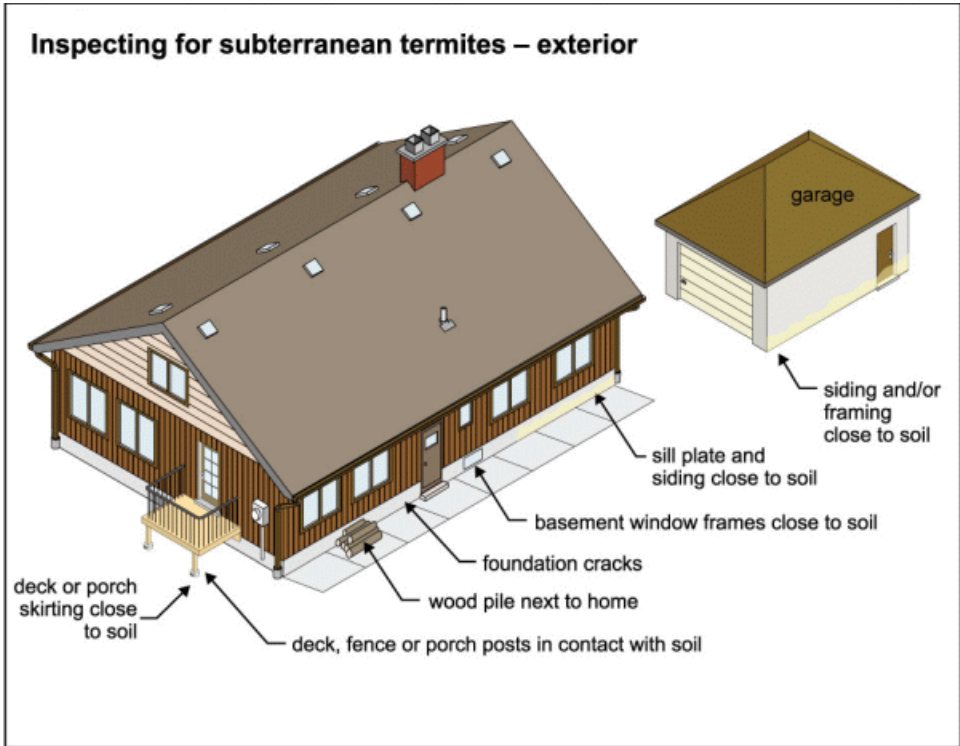
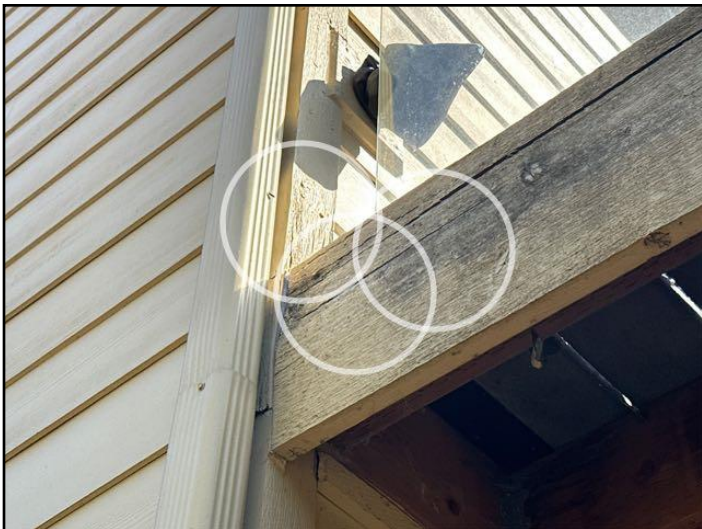
28. Rot

Condition: • [Rot](#)

There is rot and dozens of nails are popping out of the deck.

Location: SW corner upper deck. There is rot on the skirting and the trim on the corner. Center of the upper deck.

Task: Further evaluation by qualified professional recommended to repair or replace and correct issue as needed.

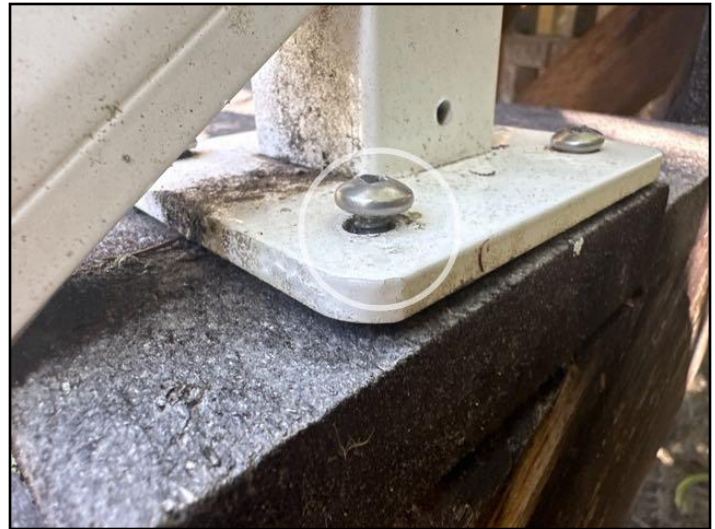
30.

Condition: • Some glass railings are detached. Some are loose. The he bolts are loose causing the railings to be wobbly.
Task: Further evaluation by qualified professional recommended to repair or replace and correct issue as needed.

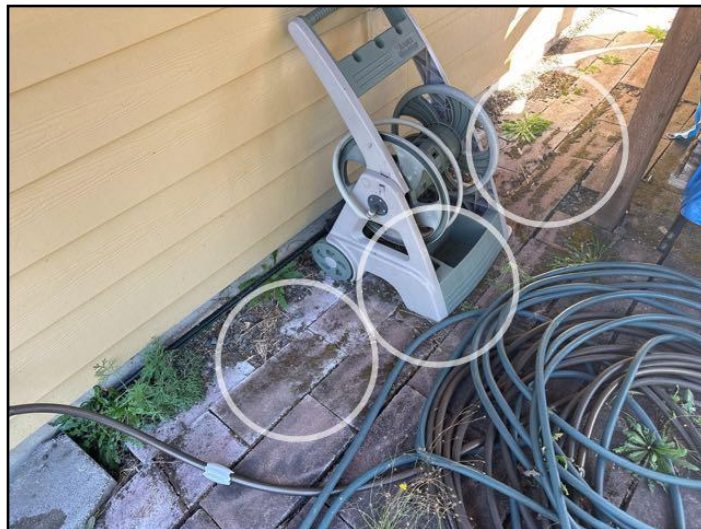
32.

Condition: • Some settlement near the house under the deck. Recommend raising the ground to help prevent water pooling.

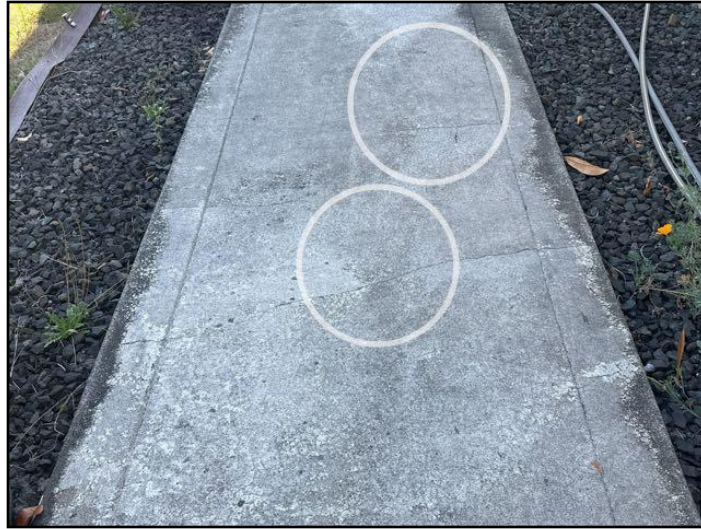
33. Cracked or damaged surfaces

Condition: • [Cracked or damaged surfaces](#)

Various Minor hairline cracks in walkway. Recommend monitor and seal gaps if they grow larger.

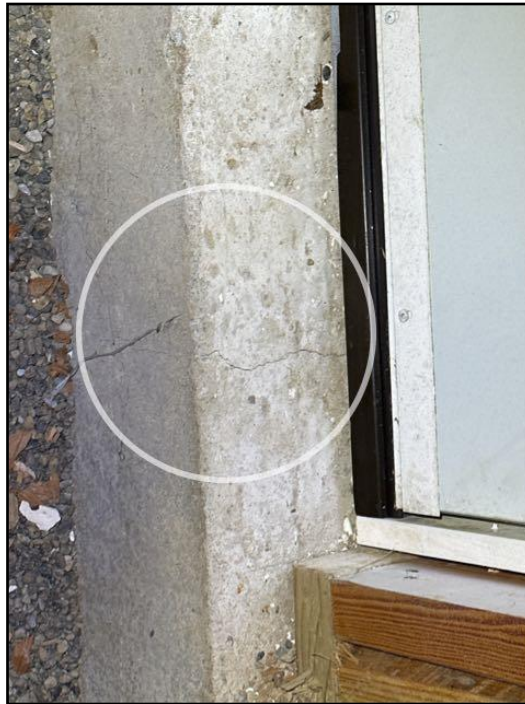
41. *Typical minor cracks*

Condition: • Typical minor cracks

Typical minor hairline cracks in crawlspace entrance and various spots

Task: No action needed

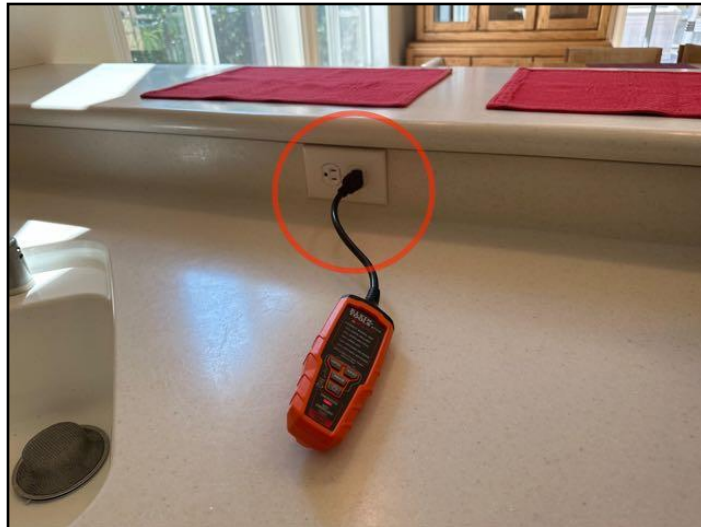
45. Test faulty on GFCI/GFI (Ground Fault..

Condition: • [Test faulty on GFCI/GFI \(Ground Fault Circuit Interrupter\)](#)

Task: Replace outlet with gfci protection

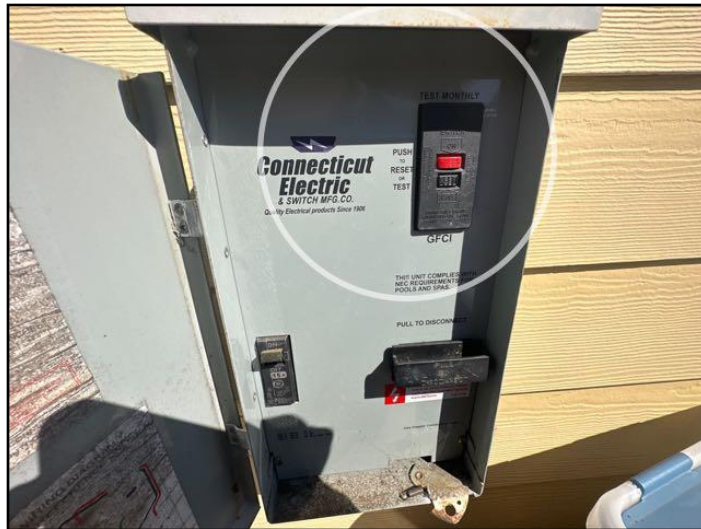
46.

Condition: • The gfci outlet for the hot tub was tripped during inspection. When I reset it the hot tub turned on and I heard a loud buzzing. I tripped the reset button to turn it back off. The tub was half empty so I did not attempt to turn it on

Task: Further evaluation by spa expert.

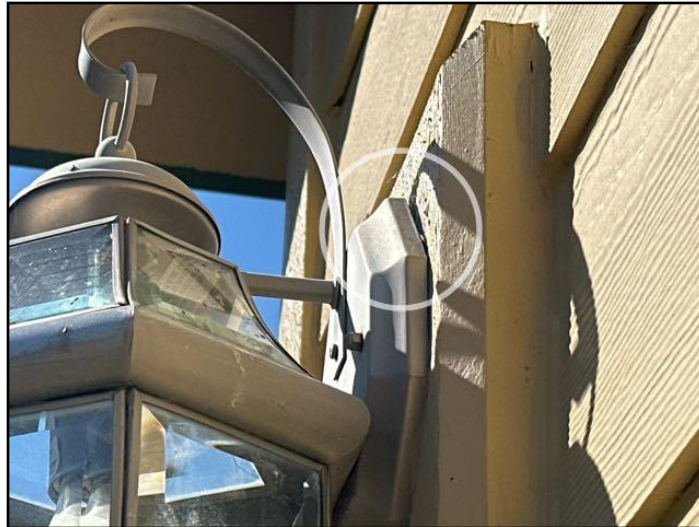
47.

Condition: • Recommend adding sealant to protect lights wires.

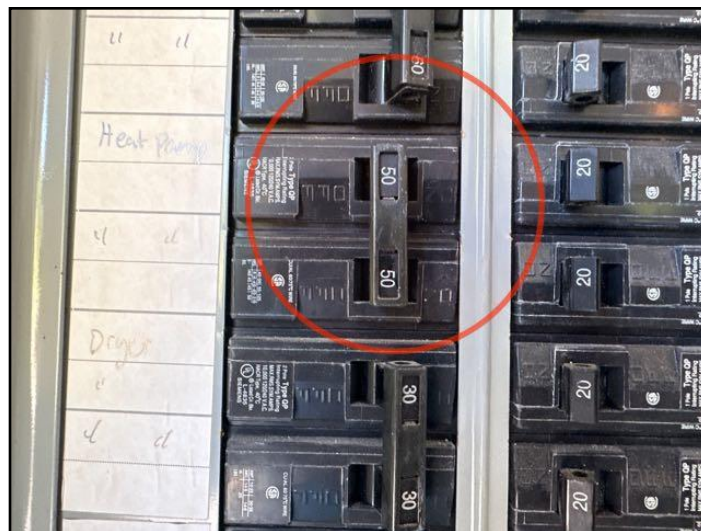
51.

Condition: • The heat pump was inoperable during the inspection. The breaker was off during the inspection. I turned it on and heard a loud humming noise and then it turned off.

Task: Further evaluation by qualified professional recommended to repair or replace and correct issue as needed.

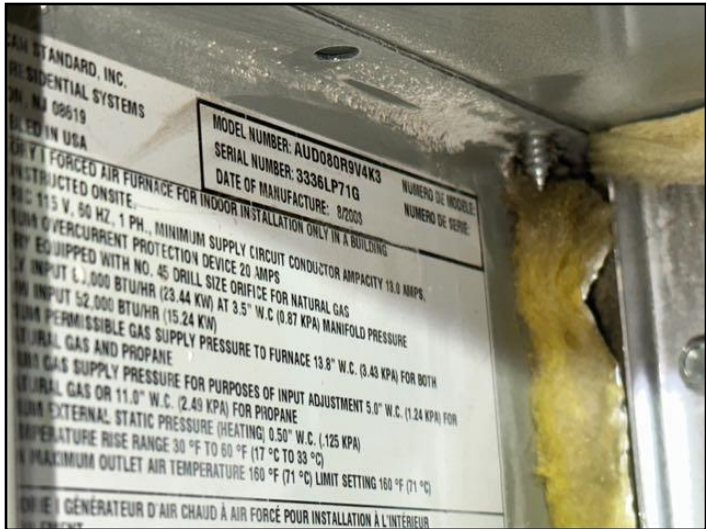
53. Near end of life expectancy

Condition: • [Near end of life expectancy](#)

Heat pump is about 19 years old and has rust.

Task: Service heat pump & furnace. Further evaluation by qualified professional recommended to repair or replace and correct issue as needed.

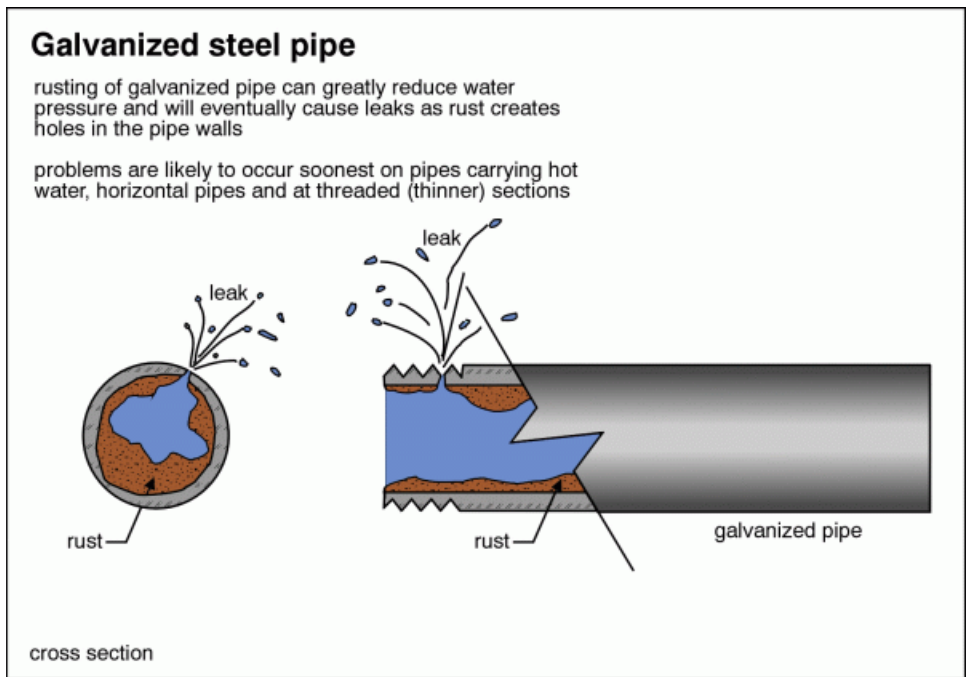
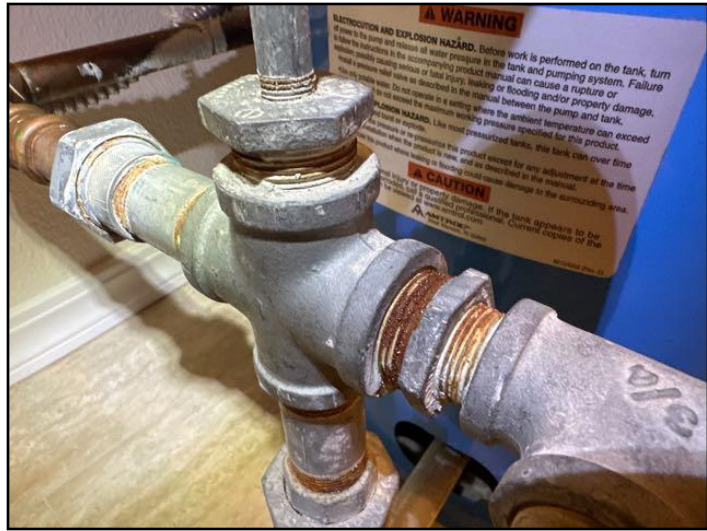
59. Rust

Condition: • [Rust](#)

Location: At the pressure tank

Task: Monitor, water with higher amounts of certain minerals may cause rust quicker in galvanized pipes.

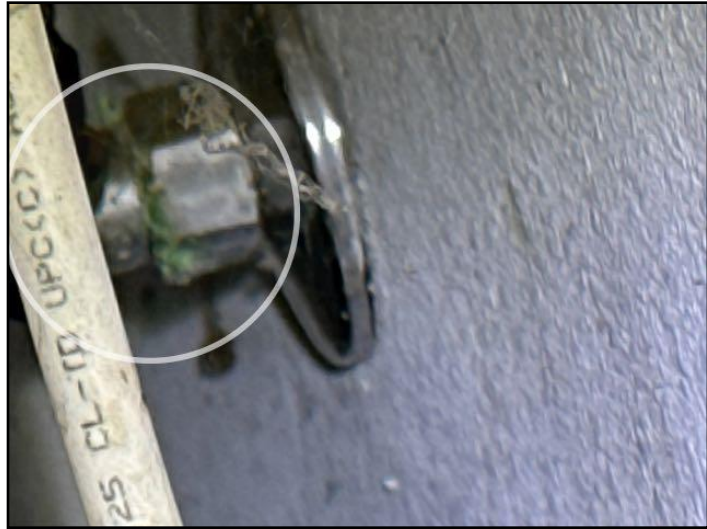
60. Corrosion

Condition: • Corrosion
Location: Garage sink copper piping connection

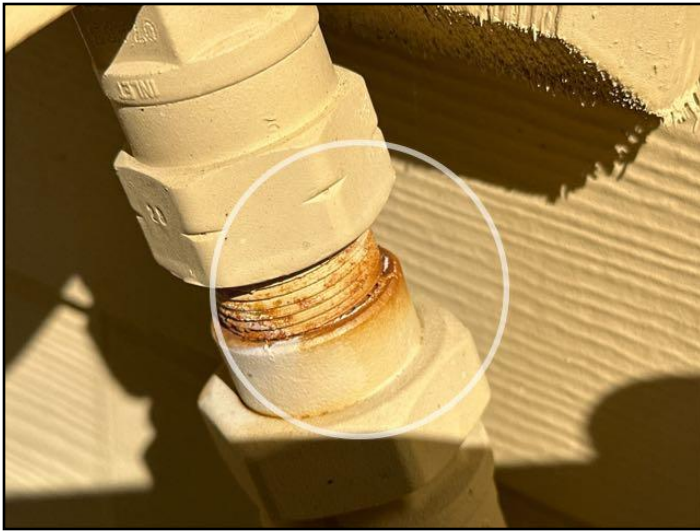
61. Rust

Condition: • [Rust](#)
Some of the gas piping is rusting
Location: By garage, by grill
Task: Remove rust with sand paper or metal brush and add rust prevention paint
Time: As soon as practical
Cost: Minor

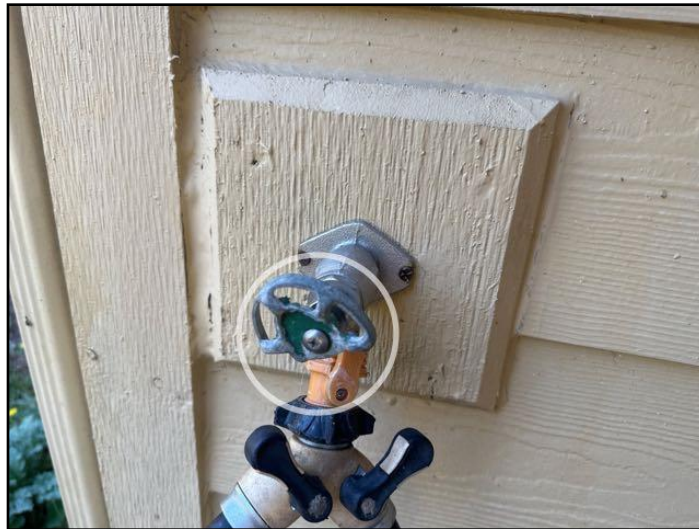
63. Damage

Condition: • [Damage](#)

The handle on the hose bib is damaged

Task: Repair if needed

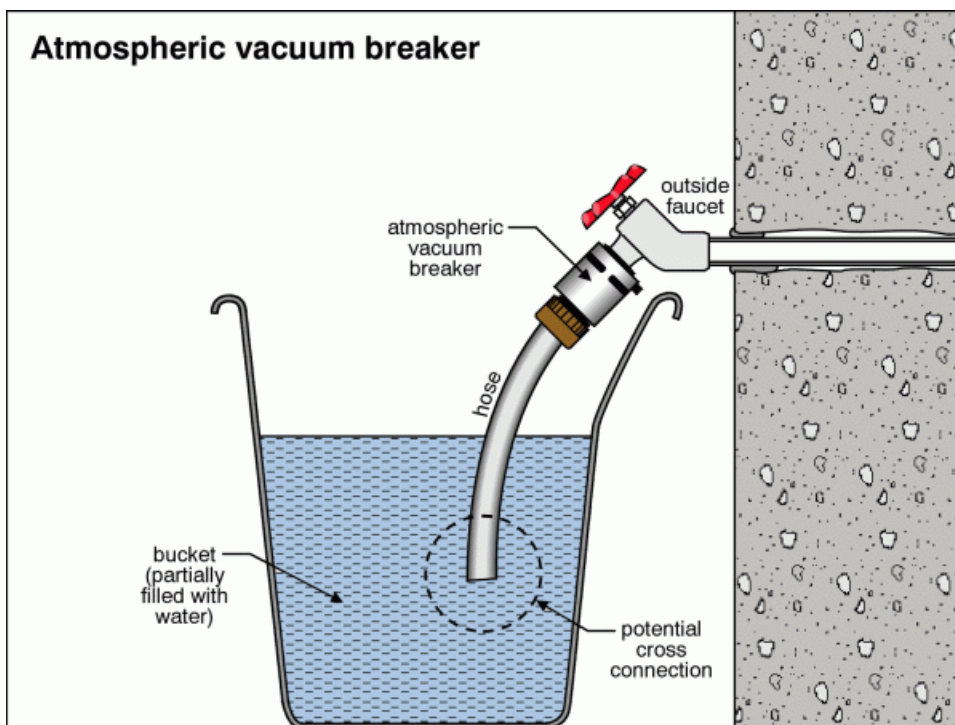
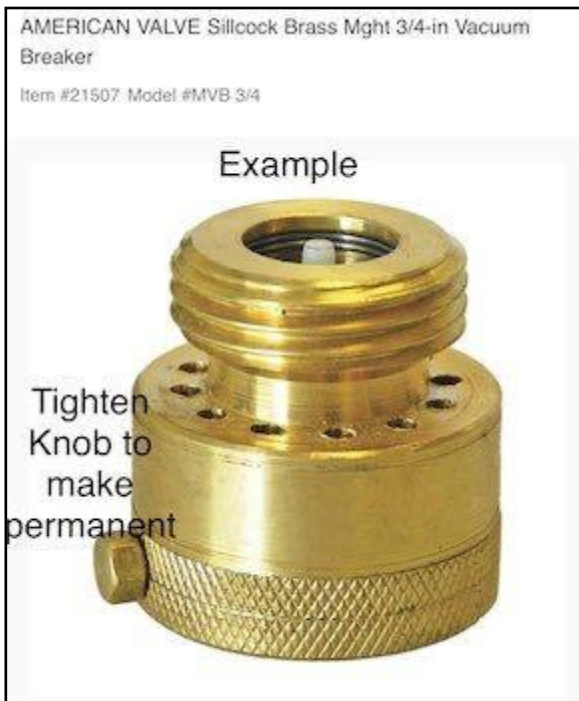
64. Backflow prevention missing

Condition: • [Backflow prevention missing](#)

Location: Front out house hose bib

Task: Provide device

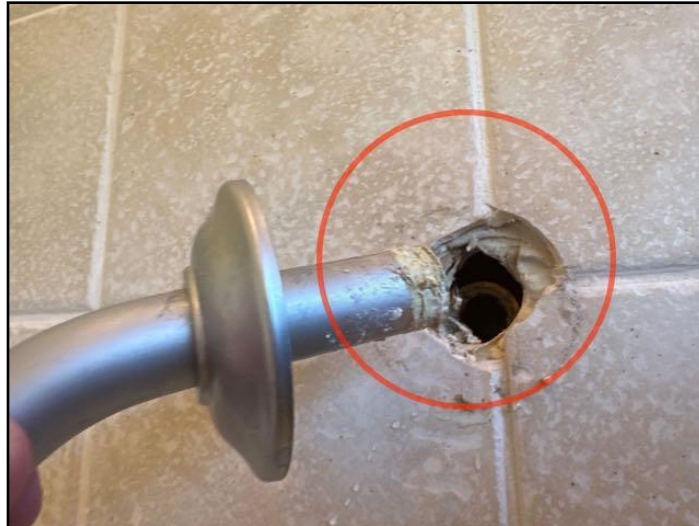
65.

Condition: • During inspection I turned the shower on and water started pouring out of the wall where the shower head

was connected. I reached up and the whole shower head fell off. There is some sort of adhesive glue which was used to try and patch the already broken shower head. Due to this issue I was unable to run shower water and inspect shower stall.

Task: Further evaluation by qualified professional recommended to repair or replace and correct issue as needed.

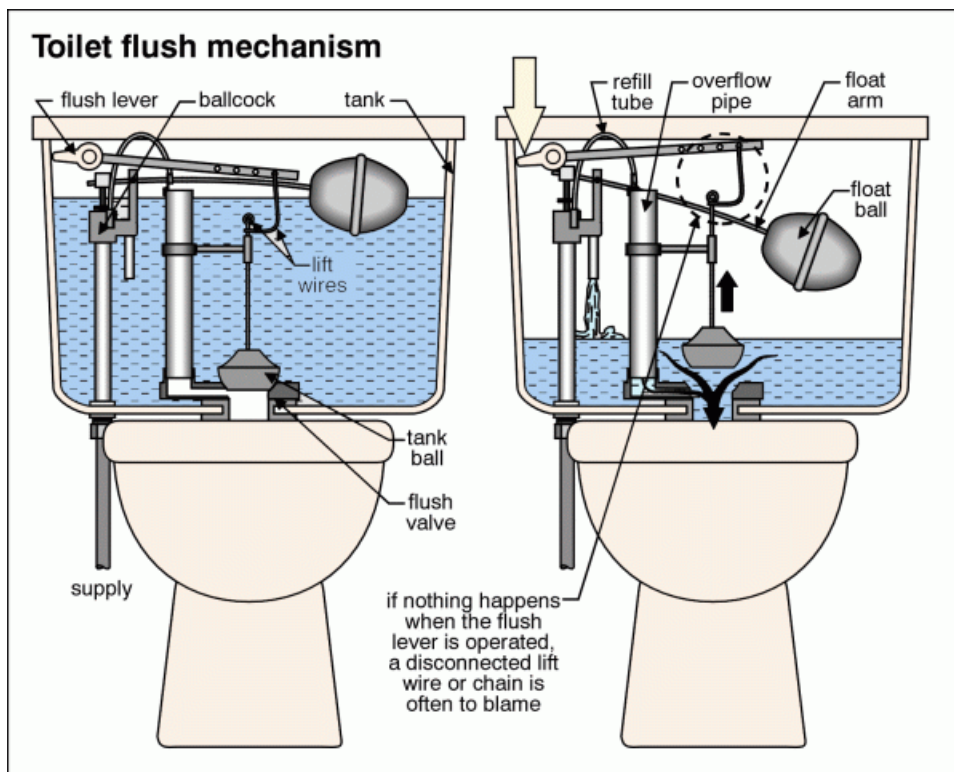
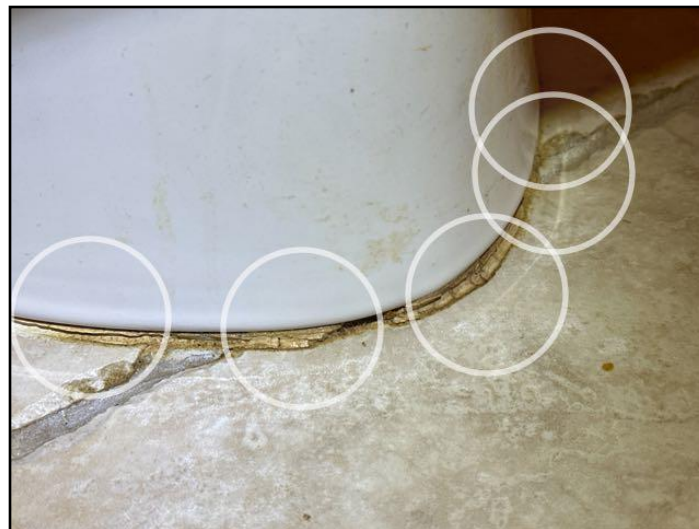
66.

Condition: • The toilet. Sulking is cracking.

Task: Replace as soon as practical

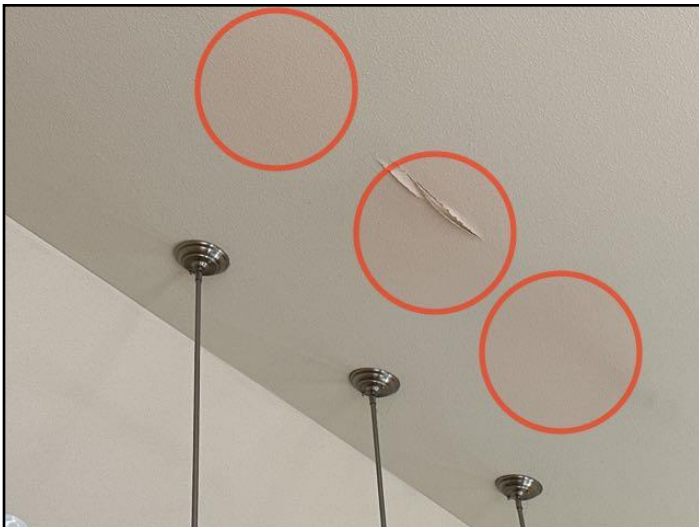
67.

Condition: • Damage to the ceilings in the living room with patch work/paint done. I am unable to determine the cause.
Location: Dining room, living room upstairs bedroom cracks in ceiling and above door,
Task: Further evaluation and evaluate the trusses near those areas.

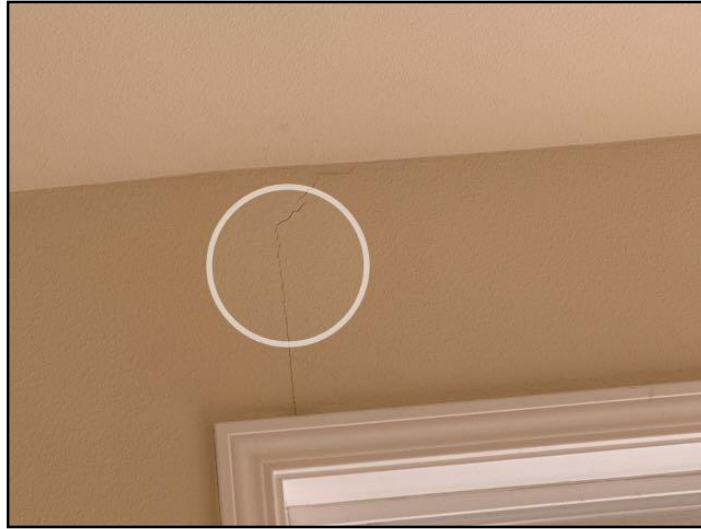
69.

Condition: • Hairline crack, possibly from typical settling.

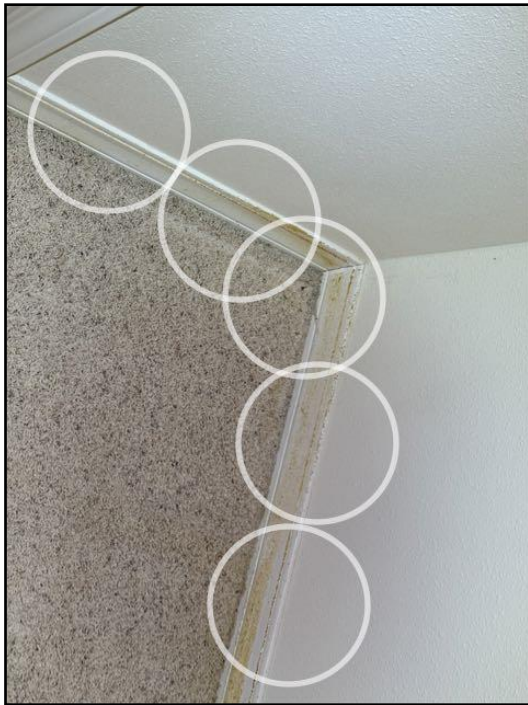
70.

Condition: • Unknown orange coloring on baseboards downstairs, in closet and on crawlspace door. It is not on dry wall, there is no swelling or crumbly dry wall but seems to only be on plastic.

Location: On room on SE corner

Task: Further evaluation

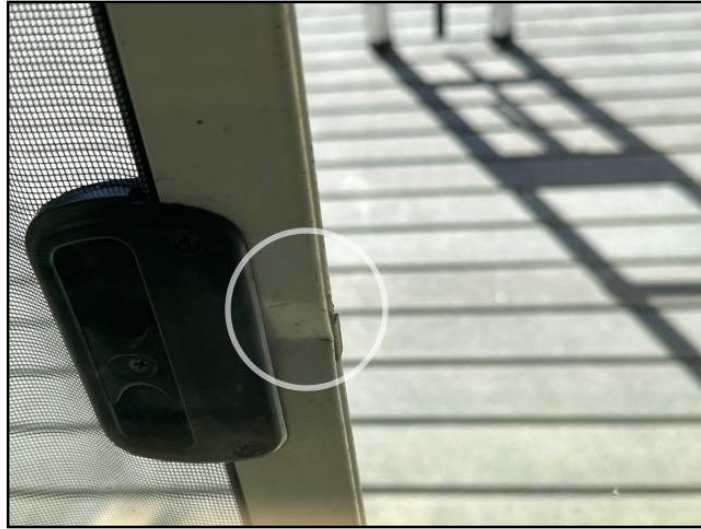
72.

Condition: • Dining room screen door is partially damaged

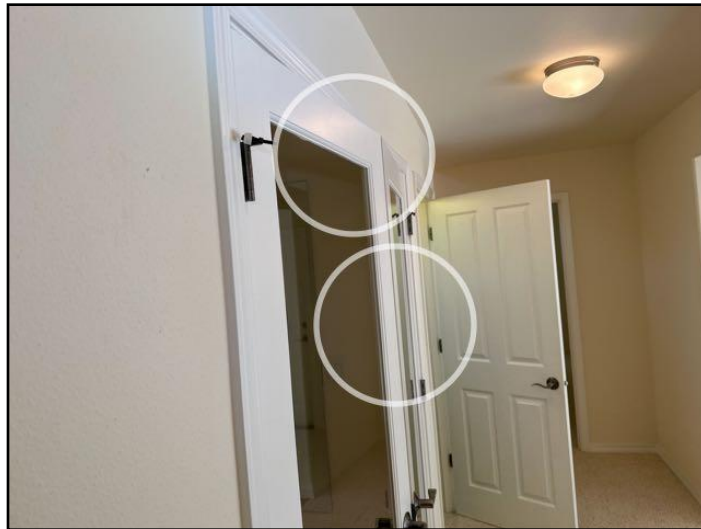
73.

Condition: • The French doors in the basement when shut aren't flush with the wall. They slowly open up a little

Task: Further evaluation and correct if needed.

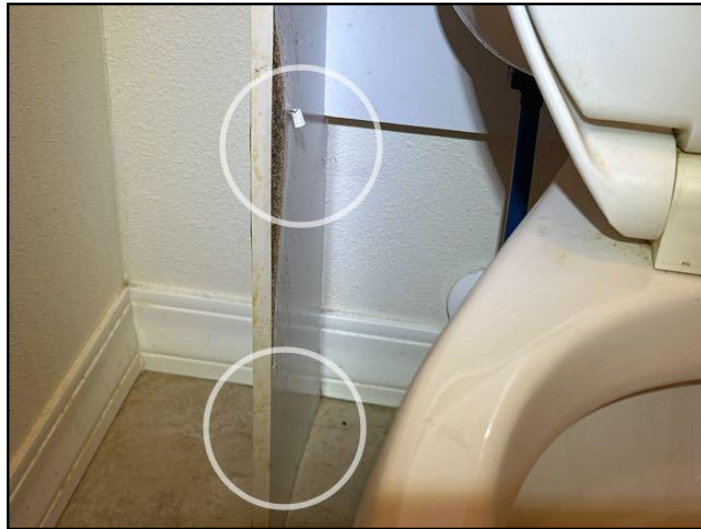
74.

Condition: • Water damage and swelling to upstairs bedroom bathroom cabinet near toilet

Task: Repair or replace if needed.

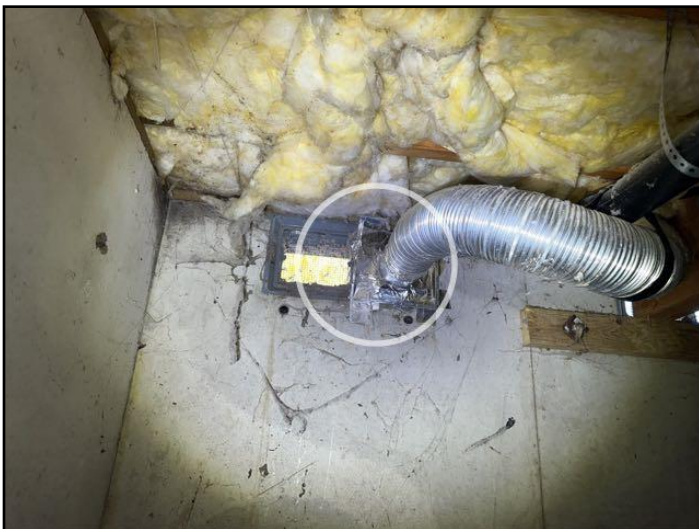
75. Vent disconnected or damaged

Condition: • Vent disconnected or damaged

Task: Further evaluation, repair, and clean up flammable lint.

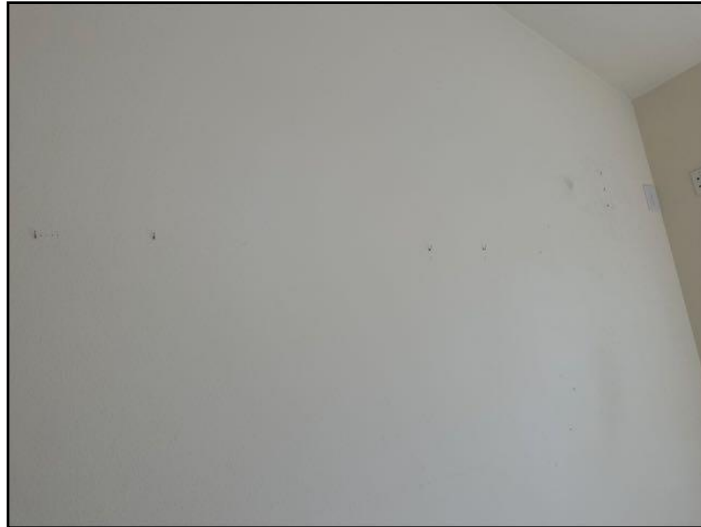
77.

General: • Patches, scrapes and nails/metal items in walls and ceilings throughout.
