INSPECTION REPORT

For the Property at:
100 INSPECTION ST
TACOMA, WA 98405

Prepared for: EXAMPLE REPORT
Inspection Date: Tuesday, September 26, 2023
Prepared by: Chad Fletcher

RE: Report No. 1366, v.0
100 Inspection st
Tacoma, WA
98405

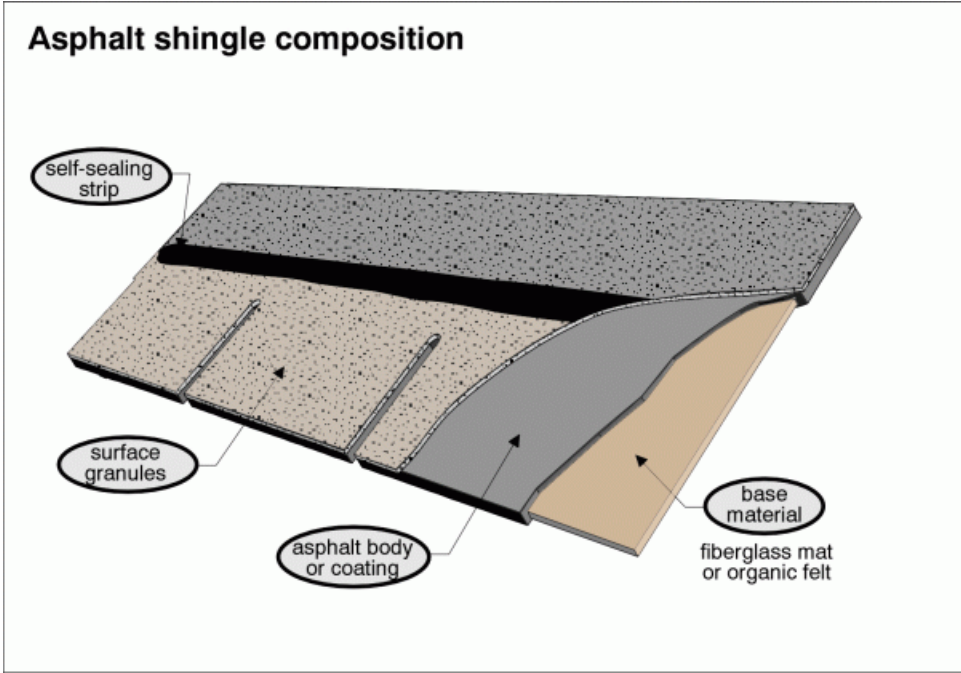
Condition: • [Granule loss](#)
Granule loss is a way to help judge the condition of the roof. The roof is approximately 20 years old. Typical life expectancy for architectural shingles is around 25 years sometimes more and some less.

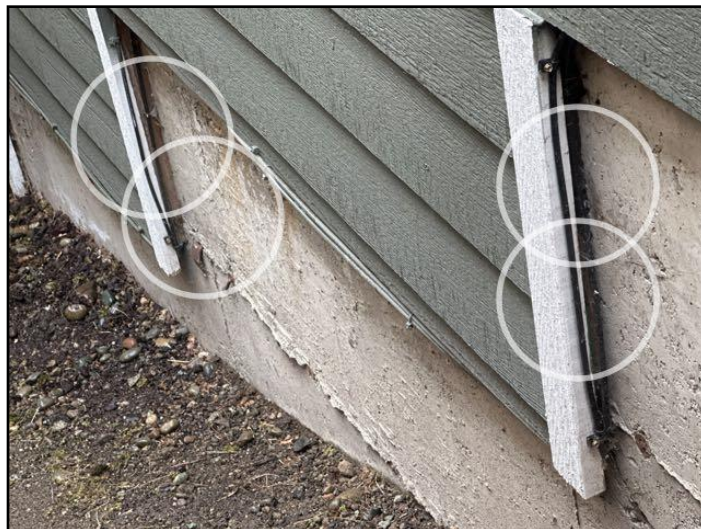
5.

Condition: • There are small gaps in the siding where unpainted wood is exposed. Recommend adding trim board, caulk and paint to protect.

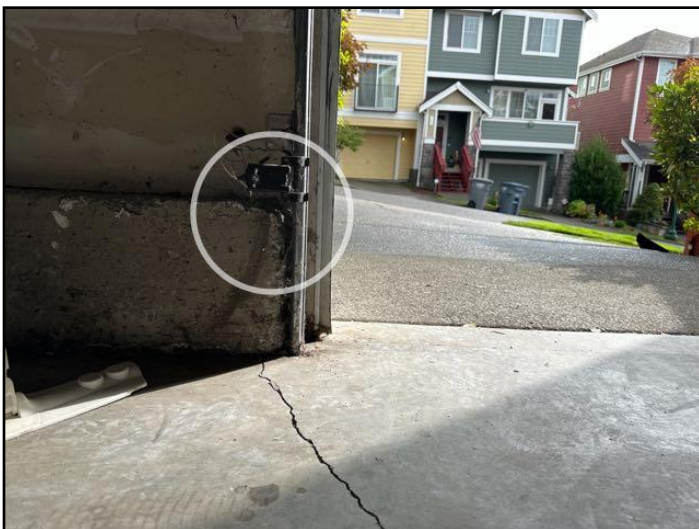
19. Sensors poorly located

Condition: • Sensors poorly located

The garage door sensors were installed too high

Task: Lower sensors for safety.

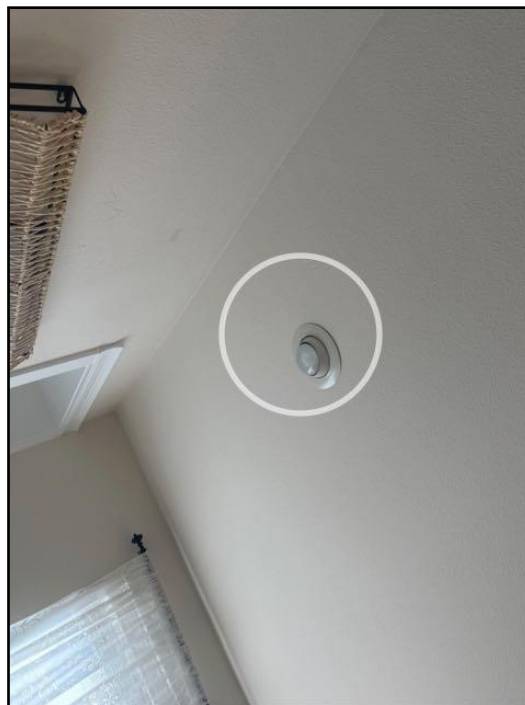
33. *Inoperative*

Condition: • [Inoperative](#)

Task: Replace light bulbs and further evaluation if that doesn't work.

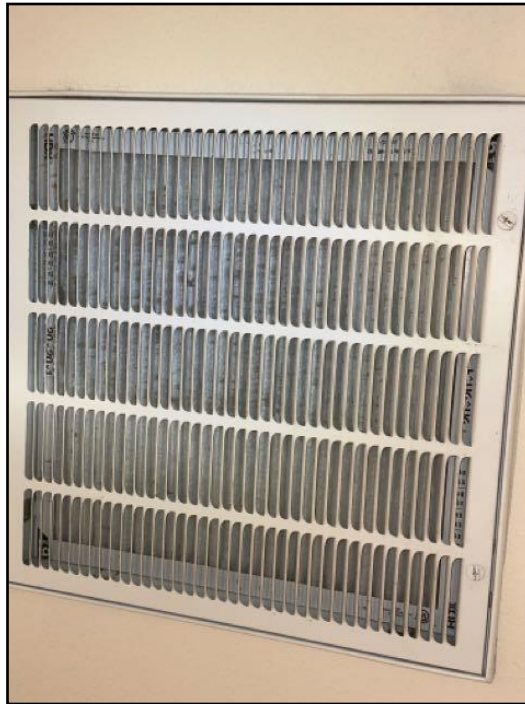
35. Dirty

Condition: • [Dirty](#)

Task: Replace filter. Replace every 6 months to a year depending on activity and use.

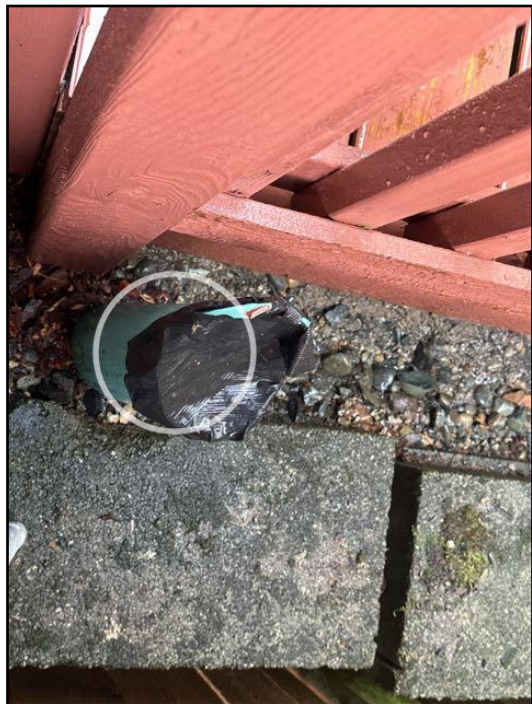
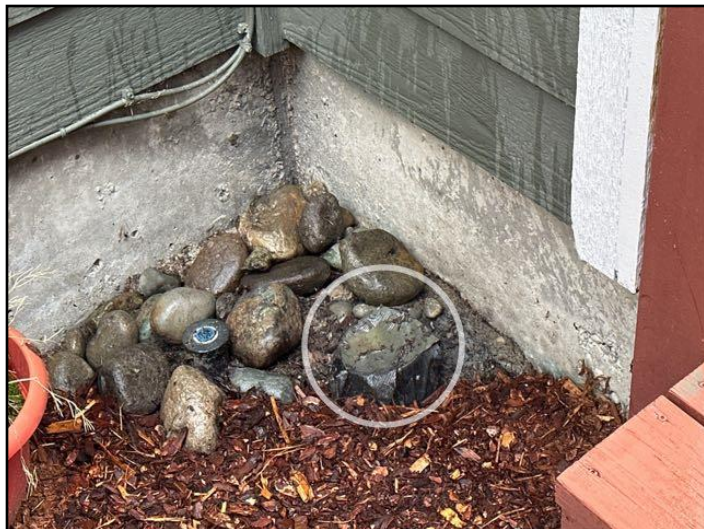
Condition: • One of the clean out stacks in the back yard is damaged and currently capped with duct tape. This currently is OK but recommend repairing the pipe and adding a proper clean out lid. There is also a clean out near the hose bib in the back yard also has duct tape and recommended the proper lid for that one as well.

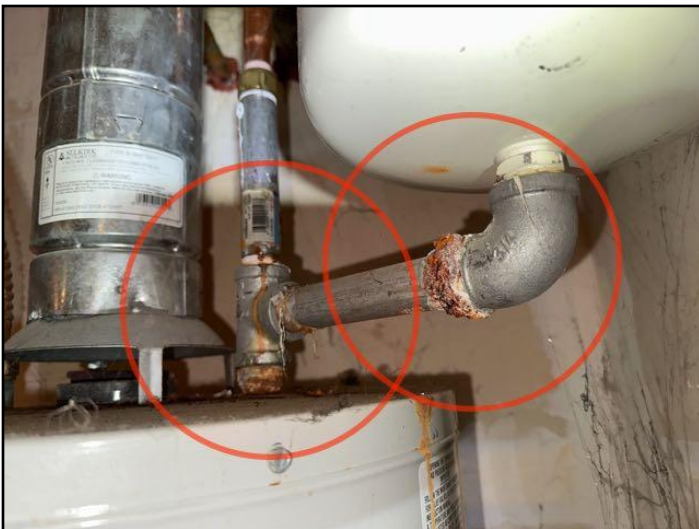
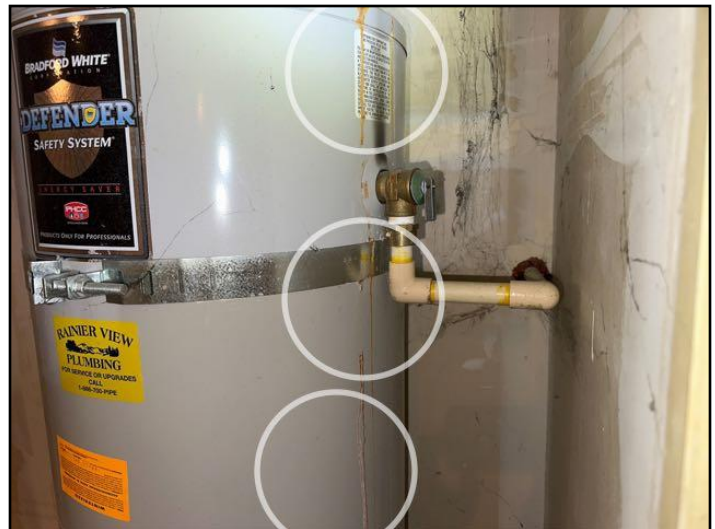
Condition: • Past life expectancy

The water heater appears to be a 2006. The tank is rusting, appears to have had leaks, and the water piping has been leaking in the last with heavy corrosion.

Task: Replace water heater and piping

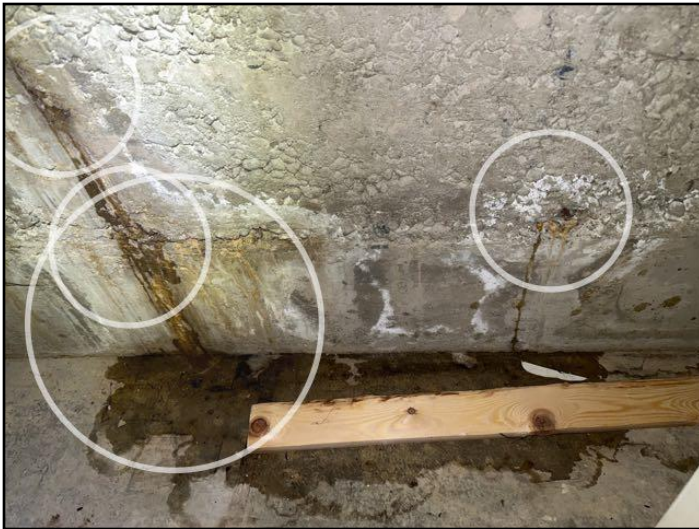
79. Dampness on floor or walls

Condition: • [Dampness on floor or walls](#)

Water is dripping from the concrete walls and there is spalling of concrete with efflorescence leaving gaps in the concrete.

Task: Further evaluation by qualified professional recommended to repair or replace and correct issue as needed.
