INSPECTION REPORT

For the Property at:
200 INSPECTION ST
OLYMPIA, WA 98502

Prepared for: EXAMPLE REPORT
Inspection Date: Friday, September 22, 2023
Prepared by: Chad Fletcher

RE: Report No. 1362, v.0
200 Inspection St
Olympia, WA
98502

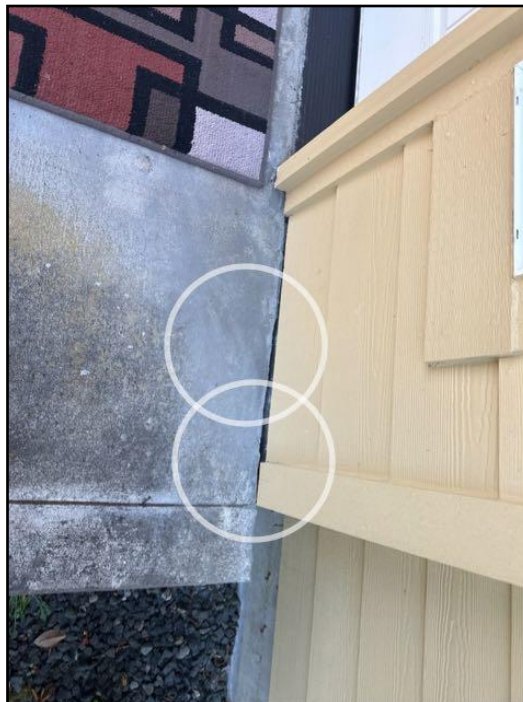
34. Unsealed gap at building
