INSPECTION REPORT

For the Property at:
200 INSPECTION ST
OLYMPIA, WA 98502

Prepared for: EXAMPLE REPORT
Inspection Date: Friday, September 22, 2023
Prepared by: Chad Fletcher

RE: Report No. 1362, v.0
200 Inspection St
Olympia, WA
98502

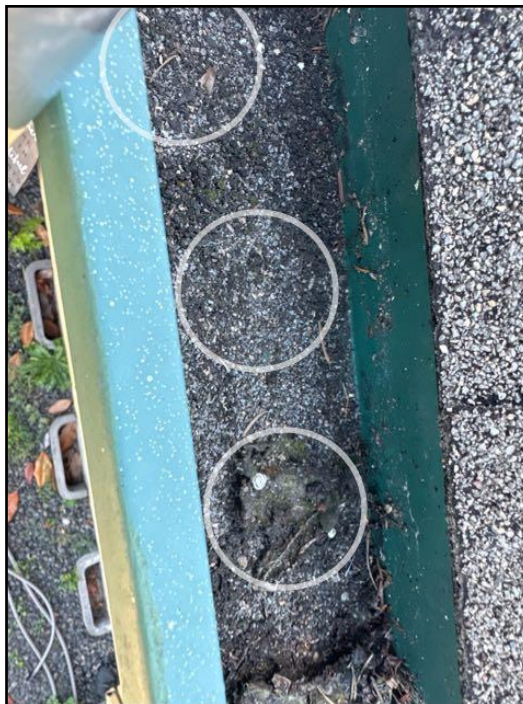
6. Granule loss

Condition: • [Granule loss](#)

Granule loss is one way to help gauge the age and condition of the roof. The granules on the roof are loose and starting to come off. You can see inside of the gutters. The roof is about 19 years old. Typical life expectancy for architectural shingles is 25 years.

Task: Budget for replacement

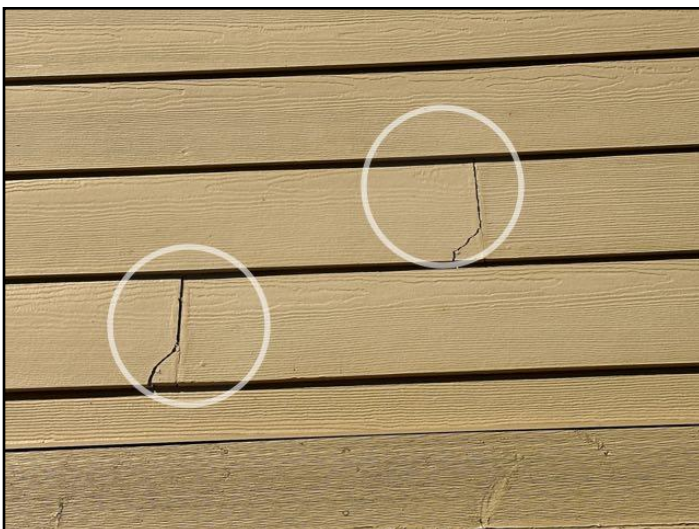
21.

Condition: • Minor damage to siding

Location: Above garage door, west wall

Task: Seal gaps, add fastnet

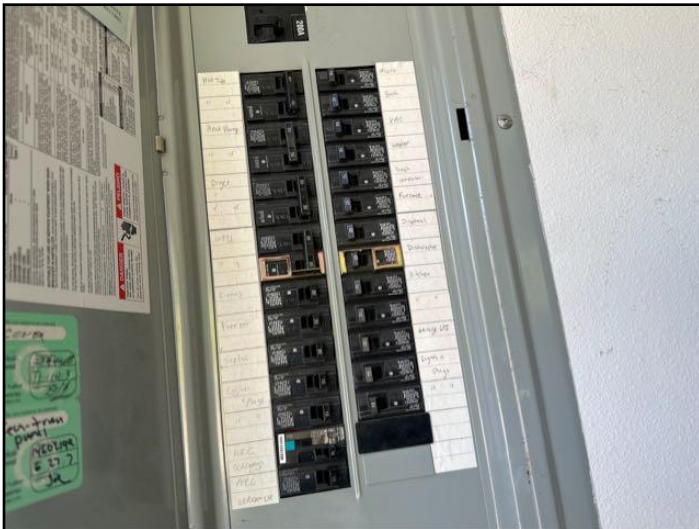
Pictures of panel. No overheating found.

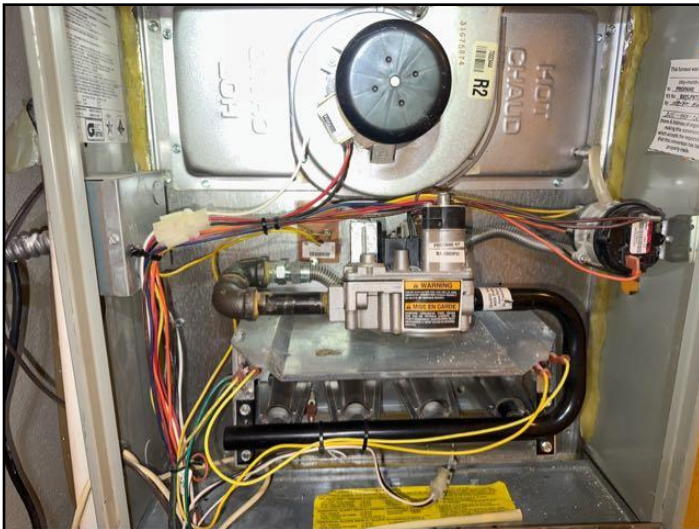
The emergency heat furnace doesn't appear to have been used much. I tested and it worked.

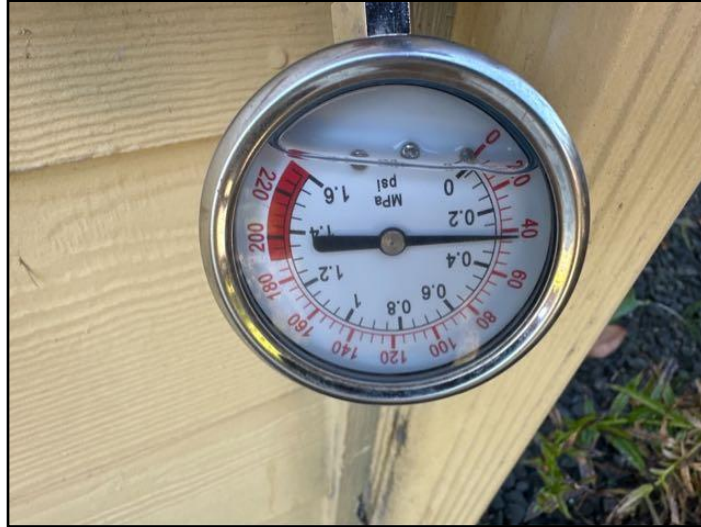
54.

General: • Water pressure is within acceptable range of 40-80PSI
